# NIMBLE THIS PROACTIVE NETWORK MAINTENANCE AND COMSONICS SIGNAL LEAKAGE TOOLS

*A Valuable System for Isolating RF Impairments that Radically Aid Drop and  
In-Home / Near Home Issue Resolution*

**NIMBLE THIS LLC AND COMSONICS INC.**

October 10, 2017 :: ver 3

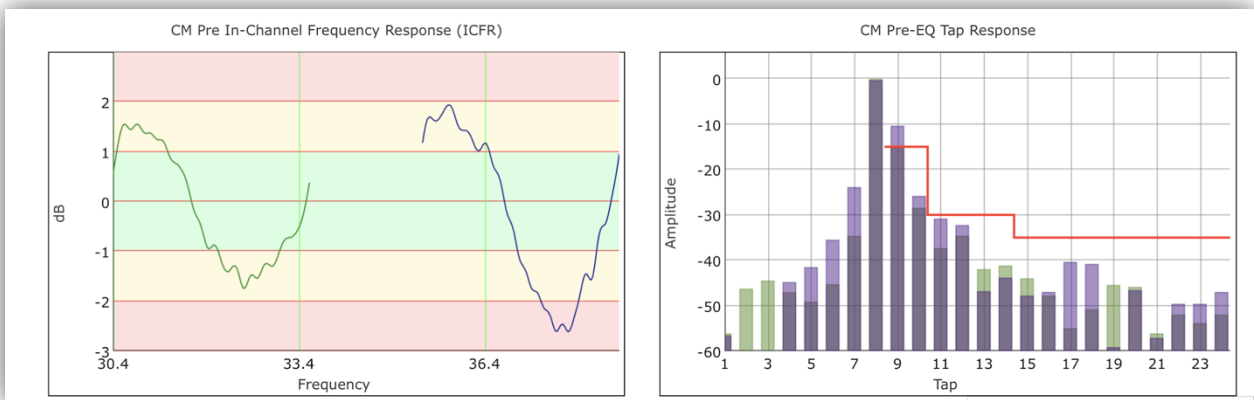
The first modem identified had significant in-channel frequency response (ICFR) and its pre-equalizer digital tap #9, shown in Figure 3, is elevated above the red threshold line.

Figure 3: Poor ICFR and Digital Tap #9 above red line (likely drop or in-home problem)

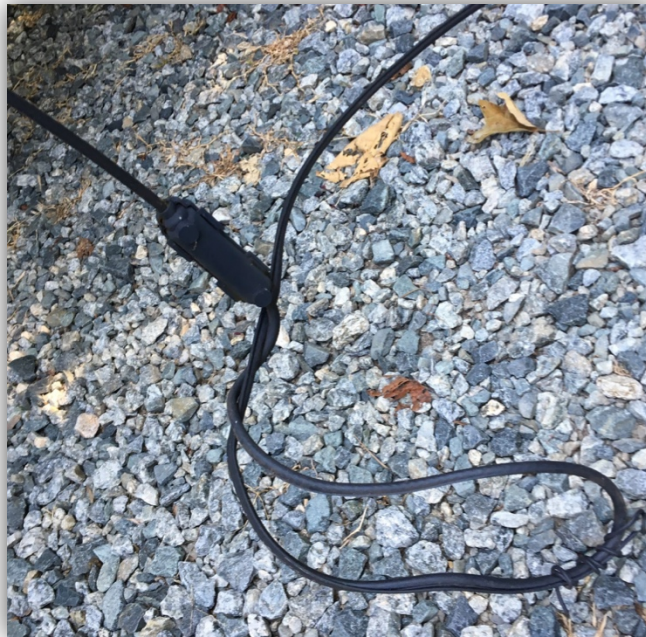
Once the M3 and QAM Compass were powered on, the technician immediately found a high level leak at the mainline tap while he was still in the bucket. There he found a splice had been

Figure 6: Inline Splice with Weather Enclosure

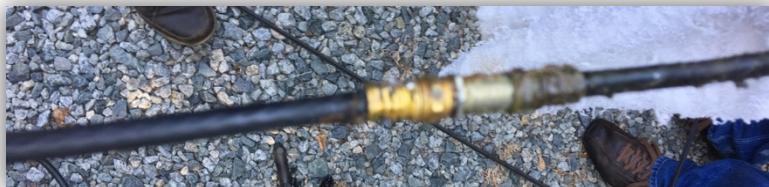
made just feet away from the tap. Figure 6 shows the splice enclosure and Figure 7 shows the connectors inside the splice enclosure, which includes two crimp-on F-connectors, one of which is severely corroded. Note that even though the connectors were in a waterproof splice enclosure, water still penetrated the enclosure and corroded the connectors. Do not count on your waterproof splice enclosure to protect your inline splices. **They will eventually fail.**

Figure 7: Corroded Crimp-on F-Connectors Exposed to Water

**Best Practice #1:** Avoid crimp-on F-connectors. Always use approved outdoor rated compression F-connectors to minimize future water ingress and corrosion, which will cause subscriber issues. It is recommended to avoid splices when possible. Further, do not count on your waterproof splice enclosure to protect your inline splices. **They will eventually fail.**

The fix was to cut off both connectors and replace with a single weatherproof Snap-N-Seal compression connector. There was enough slack in the drop to connect it directly back to the drop without the inline splice. The resulting response is shown in Figure 8.

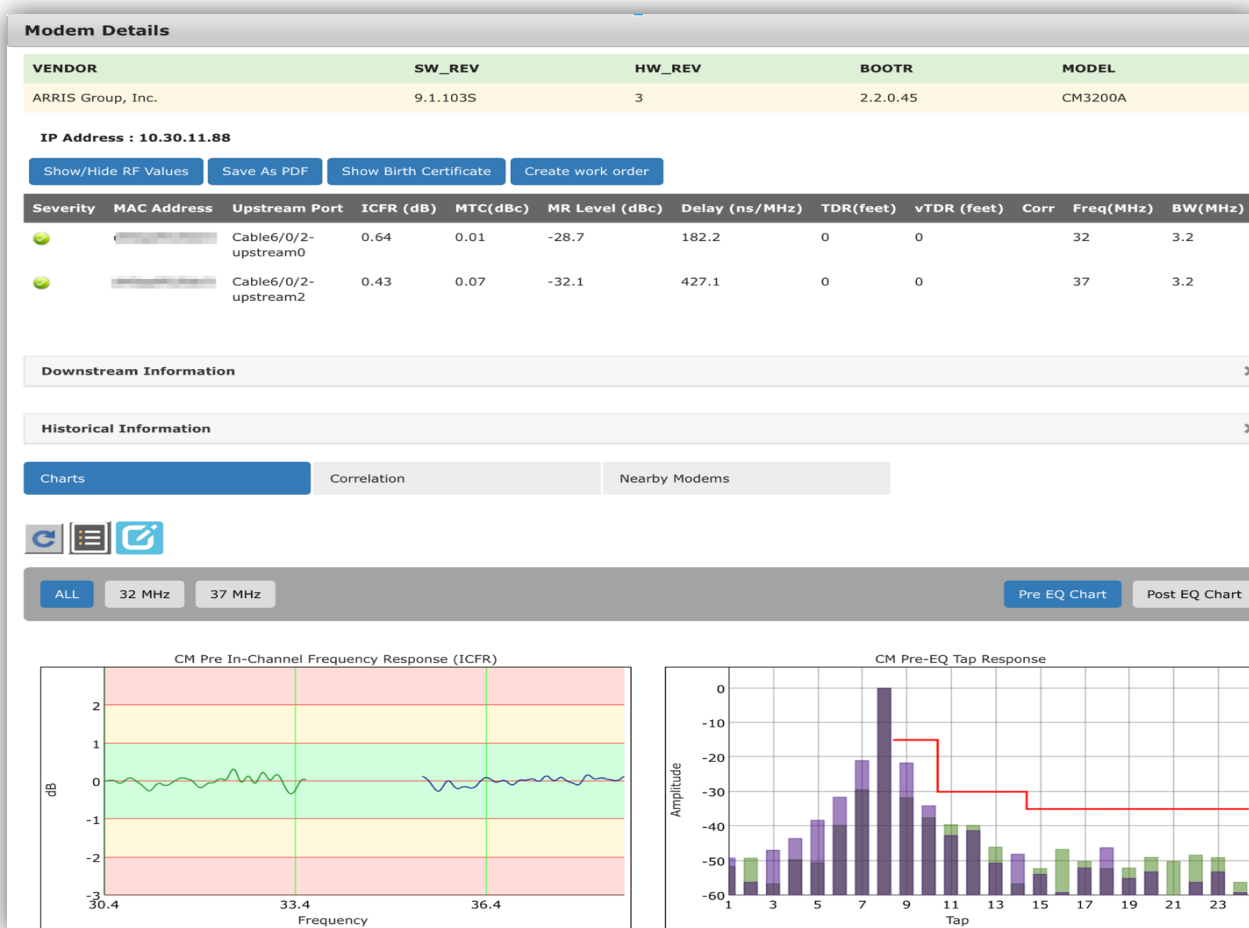
Figure 8: Subscriber 1 After Repair

Notice in Figure 8 that both upstream channels on subscriber 1's modem are now green. The MR Level (or micro-reflection level) values are down to -28.7 dBc and -32.1 dBc for 32 MHz and 37 MHz, respectively. Previously these values were at -14.56 dBc and -11.83 dBc at the same two frequencies. An ideal micro-reflection level is any value less than -25 dBc, so this is a very good upstream after the repair.

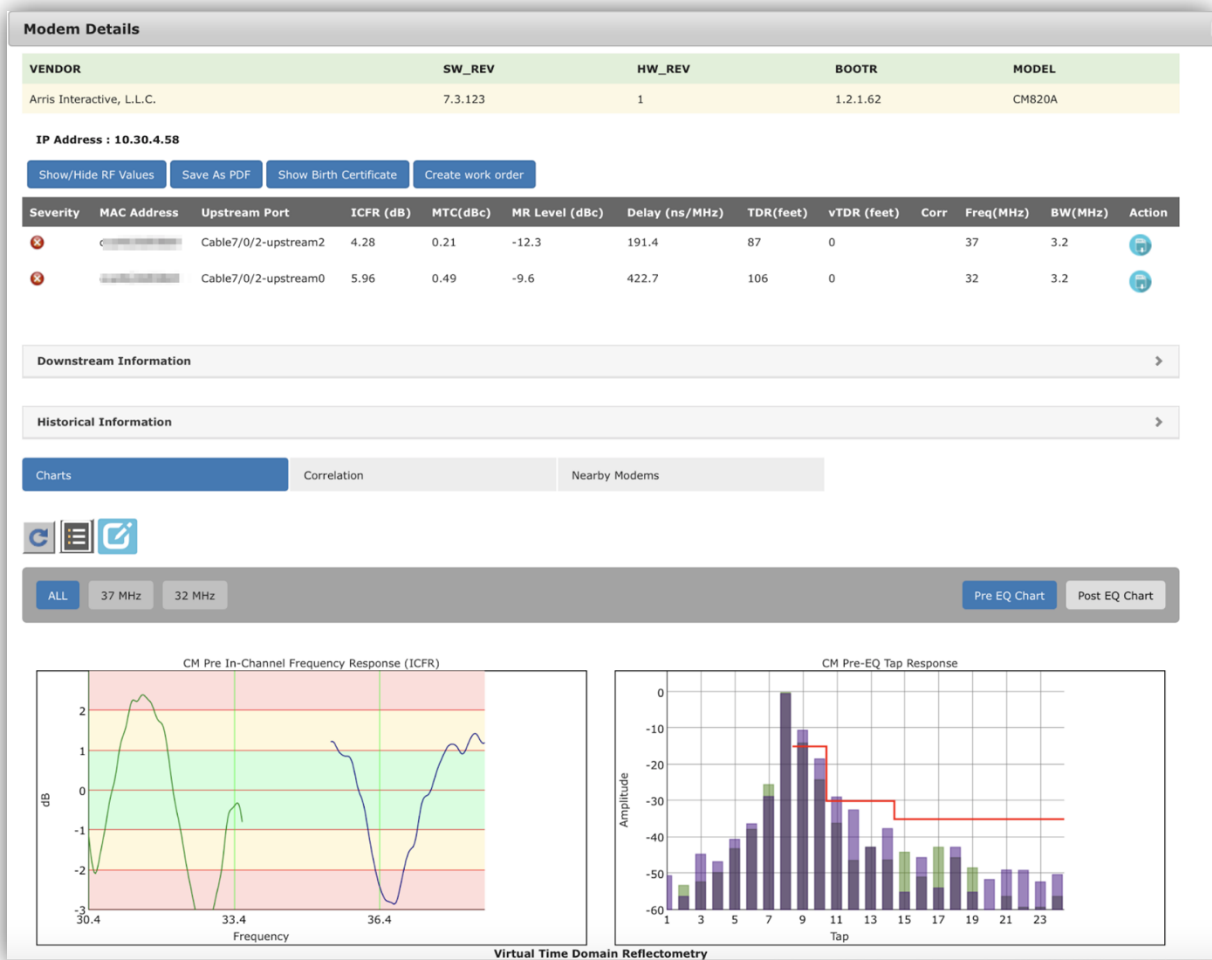
The second modem for analysis was identified with both upstream channels as having significant in-channel frequency response (ICFR) and micro-reflection levels. All surrounding modems in nearby homes were not impaired, so the confidence level was high that the impairment was either the drop or in-home related. Figure 9 shows the pre-equalizer response of the cable modem. Both digital pre-equalizer taps #9 and #10 are significantly elevated, which typically indicates a short echo cavity often associated with short span distances common to drop cables.

Figure 9: Subscriber 2 Pre-Equalizer Data

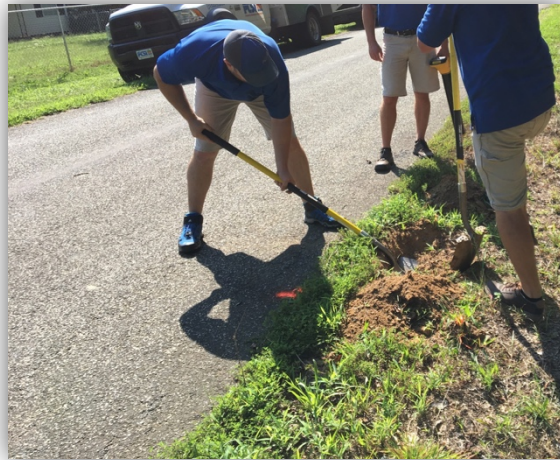
The technician walked in the direction of increasing RF signal leakage as shown on the ComSonics QAM Compass device. After several more minutes the highest level leak location was pinpointed near the road. The technicians started digging in the hopes of finding the coax cable as seen in Figure 11.

Figure 11: High Leak Location Being Excavated

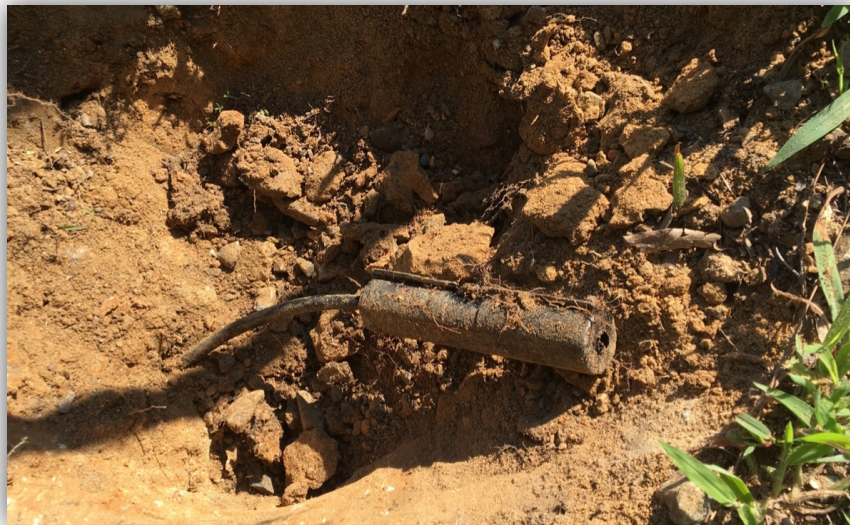
After 10 minutes of careful digging the coaxial cable was located along with a weatherproof splice enclosure. A technician pulled lightly on the splice enclosure when one end of the coax came loose from the splice enclosure indicating that the F-connector was not properly compression fitted to the cable. Figure 12 shows the splice enclosure with the missing cable.

Figure 12: Buried Splice Enclosure with Series 11 Cable Pulled from F-Connector

**Best Practice #3:** Avoid splices in buried drops. Not only are buried splices difficult to find, but unless they are in a very dry location, water ingress will almost always cause these to fail over time resulting in the splices needing to be replaced.

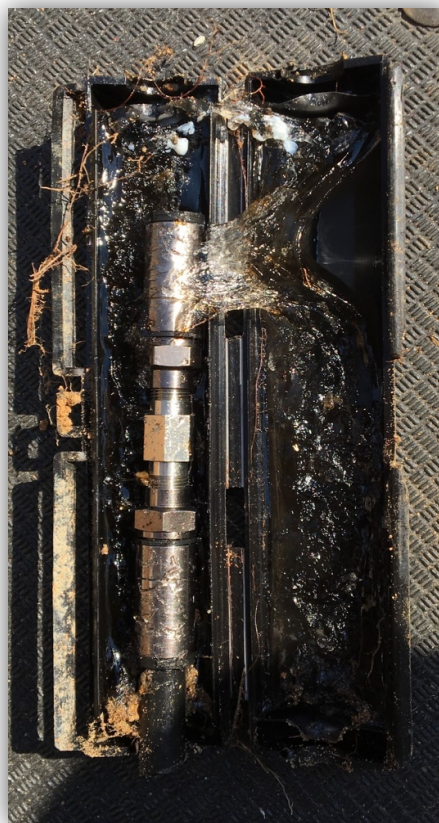
The splice enclosure was removed and opened. It was observed that quality F-connectors were installed, however the installation of at least one of the F-connectors allowed the coaxial cable to pull free. Additionally, there was water in the splice enclosure and some corrosion on the F-connectors as can be seen in Figure 13.

Figure 13: Opened Splice Enclosure with Water Ingress and Corrosion

A temporary drop was connected to the existing splice. A permanent drop will be installed in the future when the drop can be buried under the adjacent road without a splice. Once the temporary splice was in place all signal leakage stopped as measured by the ComSonics' QAM Compass. The modem was then rescanned using the Nimble This PNM mobile application. The modem performance improved significantly, however it still showed an RF impairment with an echo cavity of roughly 500 feet, which was approximately the length of the newly spliced drop combination. Since no other adjacent subscribers showed this same impairment it was deduced that the impairment was isolated to this subscriber's home. No additional leaks were detected from the drop or near the home. Consequently it was not necessary to go inside the home as leakage inside the home is normally detectable from outside of the home too. Therefore, we focused on all hardened devices on the drop.

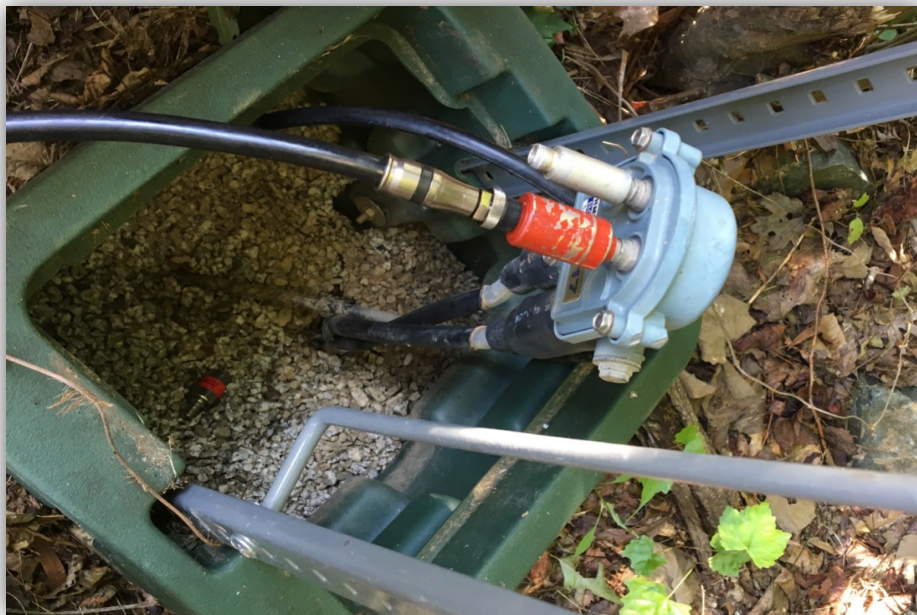
A data-only trap was found at the mainline tap. This device is used to allow only the DOCSIS SC-QAM channels to pass, while it blocks all other video channels. It can be seen in Figure 14 as the red object connected to the tap.

Figure 14: Bad Drop Trap Causing a Micro-Reflection

The red filter was removed and replaced with a new one. It is possible that the filter was damaged by lightning or failed with age. Upon rescanning the cable modem with the Nimble This PNM application the modem returned a near perfect upstream response as seen in Figure 15.

**Best Practice #4:** If you live in an area where lightning is prevalent be sure to check traps, filters and terminators for lightning damage. Most of these devices have small components which will fail if lightning strikes nearby the drop or mainline coax cable, causing micro-reflections.

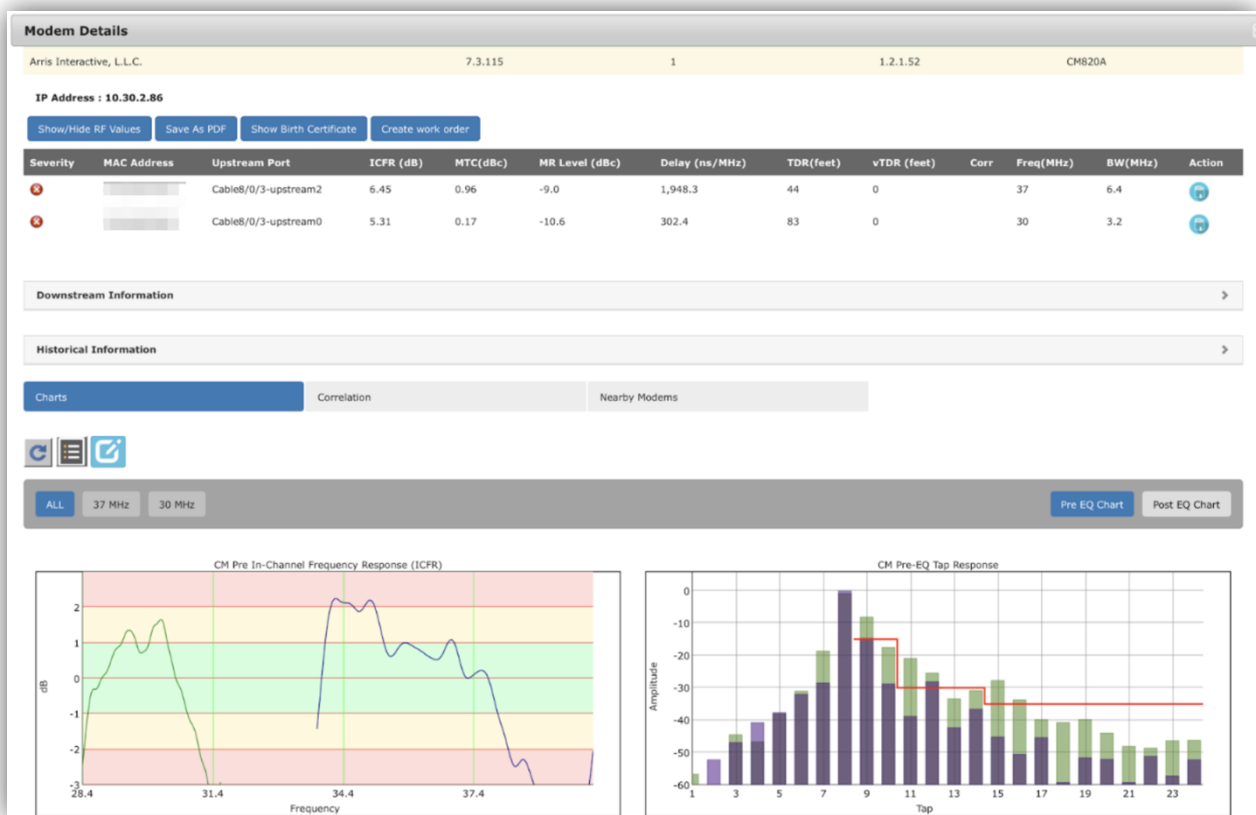
The next modem was again selected based on having poorly performing upstream channels, each with high micro-reflections and digital taps #9 and #10 elevated. Further, no other adjacent homes were experiencing similar characteristics. Figure 16 shows the modem's response before the repair.

Figure 16: Subscriber 3 Modem Before Repair

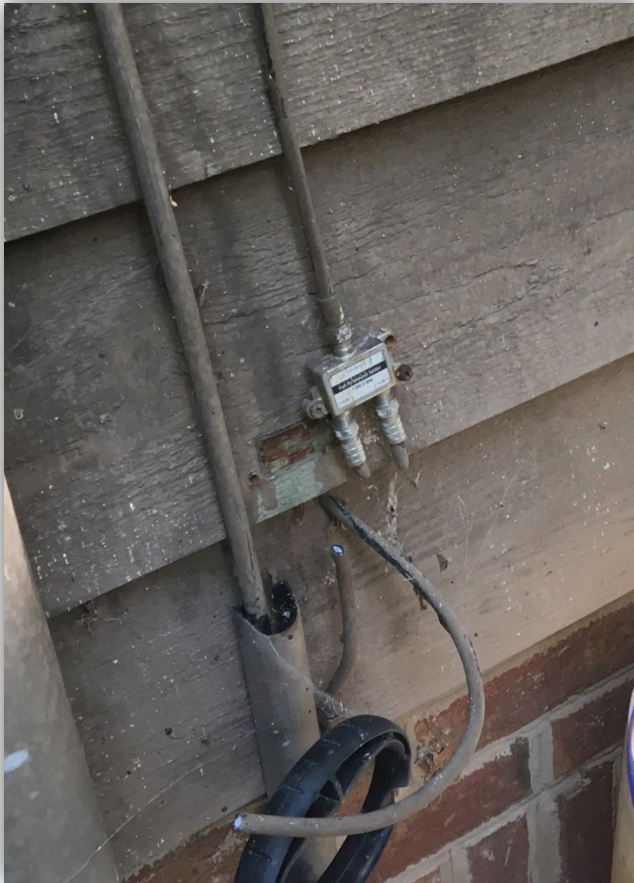
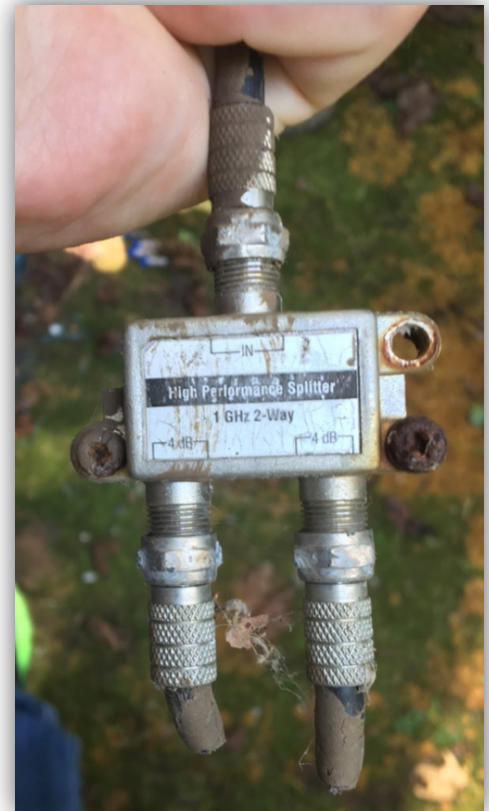
Upon connecting the ComSonics M3 to the subscriber drop substantial leakage was detected by the QAM Compass along the entire underground drop path. The technician followed the leakage to the side of the subscriber's home where a non-cable company splitter and twist-on[2] F-connectors were discovered as shown in Figure 17 (note the picture was taken just after the technician cut the cable at the output side of the splitter).

Figure 17: Old Splitter and Twist-on F-Connectors

The splitter was removed and terminated at the single twist-on F-connector feeding the splitter, but substantial RF leakage was still detected. This indicated the primary source of leakage was the single twist-on F-connector. All twist-on F-connectors were replaced with

weatherproof Snap-N-Seal compression F-Connectors and the splitter was replaced and relocated to the existing house box.

**Best Practice #6:** Locate all splitters in a weather protected house box or inside the subscriber's home or MDU (multi-dwelling unit). Unprotected splitters will rust and corrode causing premature failure and micro-reflections. Be sure to weatherproof all outdoor F connectors, even those installed in house boxes.

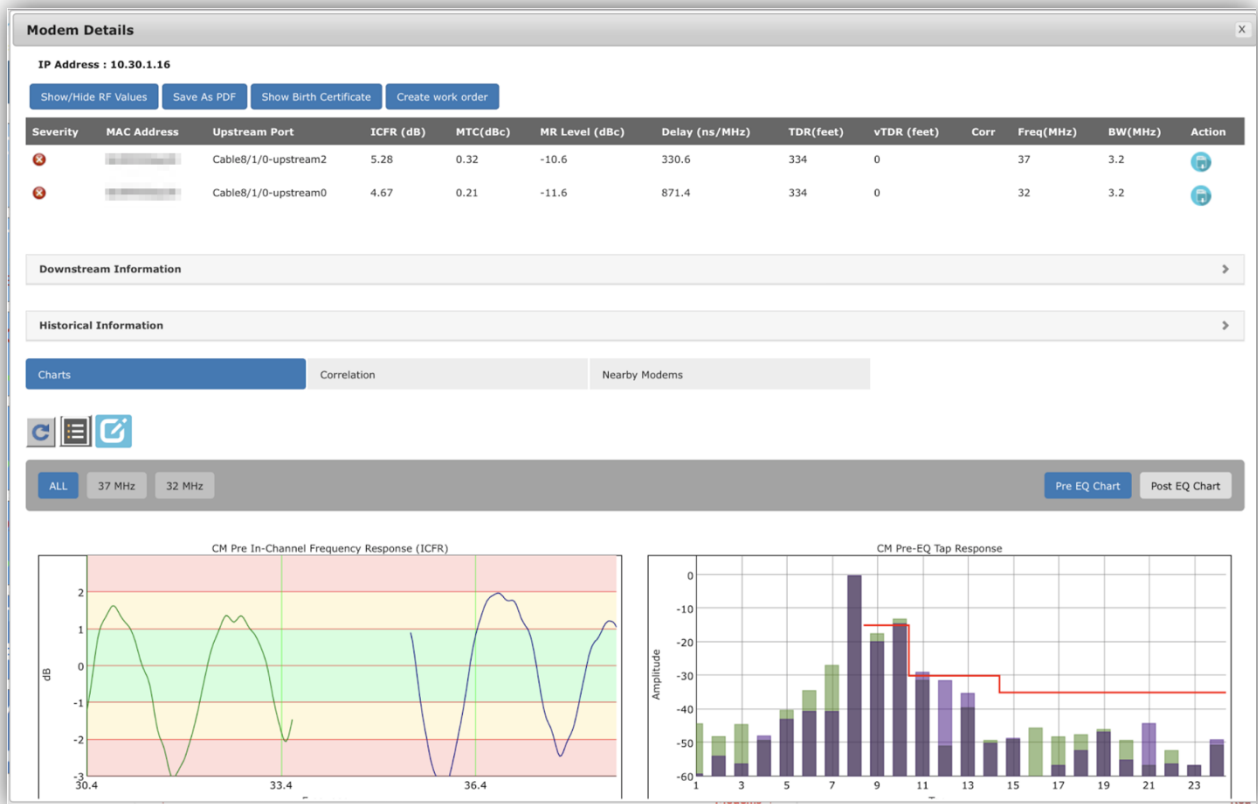
troubleshooting approach was used as with other subscribers in this field study, however it was apparent that the RF leakage was emanating from inside the subscriber’s home.

Figure 19: Subscriber 4 Modem Response Before Repair

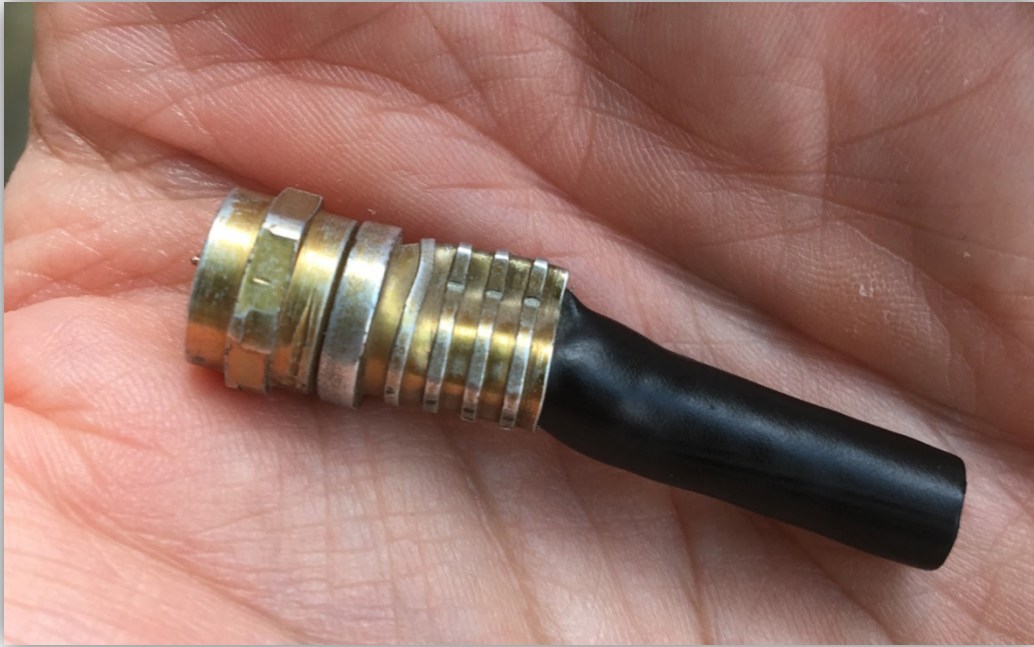
Upon entering the home the ComSonics’ QAM Compass quickly led the technician to the strongest source of the signal leakage, at the back of the cable modem. The technician found a crimp on F-Connector on the back of the cable modem. As soon as the connector was cut off the leak stopped immediately. The crimp-on-connector was replaced with a quality compression F-connector. Additional leakage was traced to a crawl space, but it was not significant and the technician indicated that he would return later to repair this minor leak.

Figure 20: Crimp-on F-connector On Back of Modem Causing Micro-Reflection

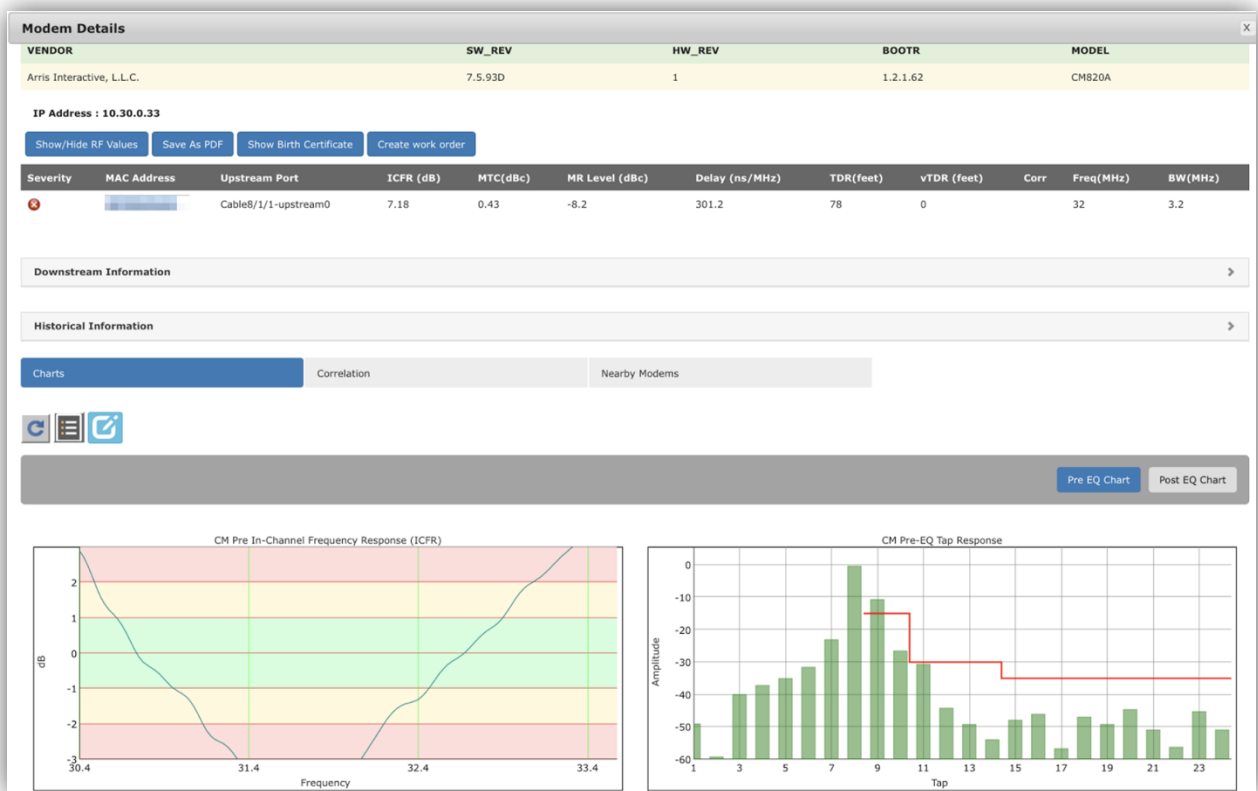
Figure 22 shows the modem's upstream response, with only one channel at 32 MHz and a micro-reflection level of -8.2 dBc. No adjacent subscribers were having this same issue and digital tap #9 is the highest amplitude, indicating a likely drop, near home or in-home related impairment.

Figure 22: Subscriber 5 Before Repair

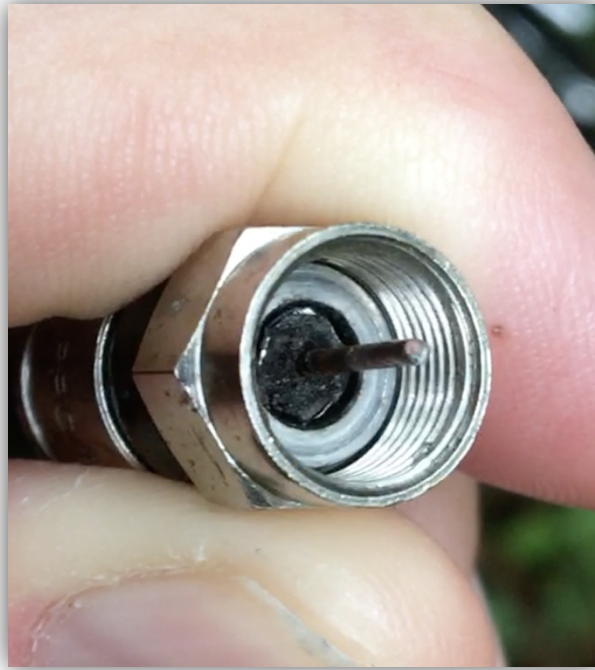
The technician removed the aerial drop and put it on the ground. It was inspected from one end to the other. While the drop showed no signs of physical damage from the outside, one F-connector showed possible signs of electrical surge as observed in Figure 23, where the insulating dielectric and center conductor were blackened. A significant electrical surge could have seriously damaged the drop at a bend location or perhaps along the entire drop cable causing RF leakage throughout.

Figure 23: Blackening of Center Conductor and Insulating Dielectric Indicating Possible Surge

Upon replacing the drop cable all signs of RF leakage disappeared. Further, upon reconnecting the drop and rescanning the modem using the Nimble This PNM mobile app it was found that not only had the original upstream channel turned from red to green, but the modem was no longer in partial mode. Now the modem was able to bond to both upstream channels and both upstream channels were green with minimal micro-reflections, as can be seen in Figure 24.

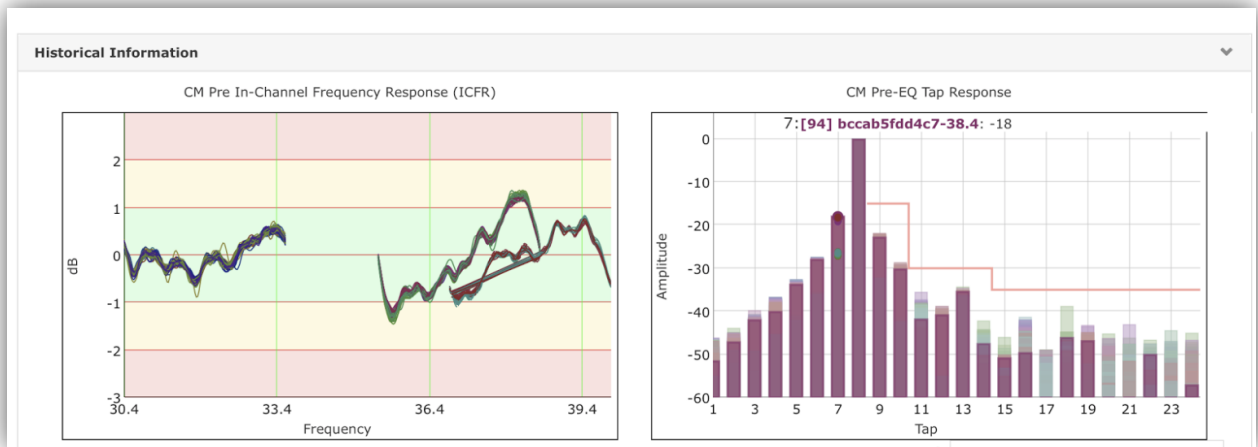
Figure 25: Subscriber 6 Modem Before Repair

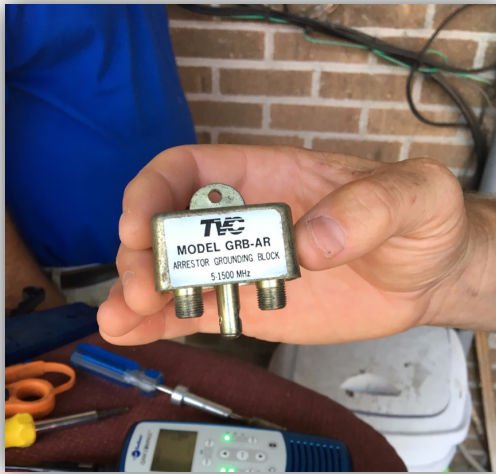
Impairment Found: Intermittent issue due to faulty TVC Arrestor Ground Block. The faulty ground block shown in Figure 26 was only detected because it was leaking significant amounts of ComSonics' M3 RF energy. Faulty ground blocks are not common, but it is assumed this "surge arresting" type ground block had been damaged by a surge.

Figure 26: Faulty Surge Arresting Ground Block

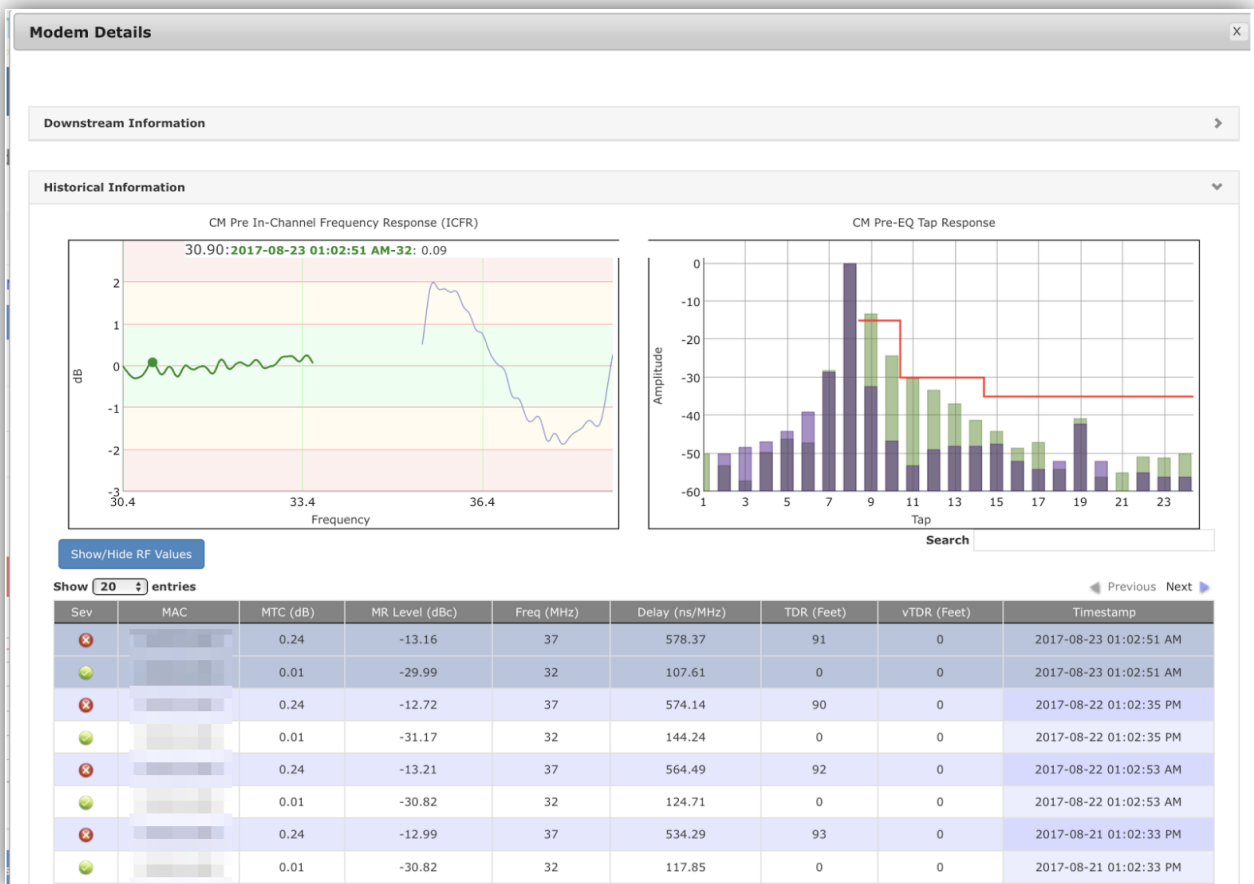
Figure 28: Subscriber 7 Modem Before Repair

Impairment Found: Multiple leaks inside the house due to crimp-on style F-connectors and an unnecessary house-amp in front of the modem. Upon replacing all older style connectors with quality connectors, no leaks were observed, and the modem response in Figure 29 resulted.

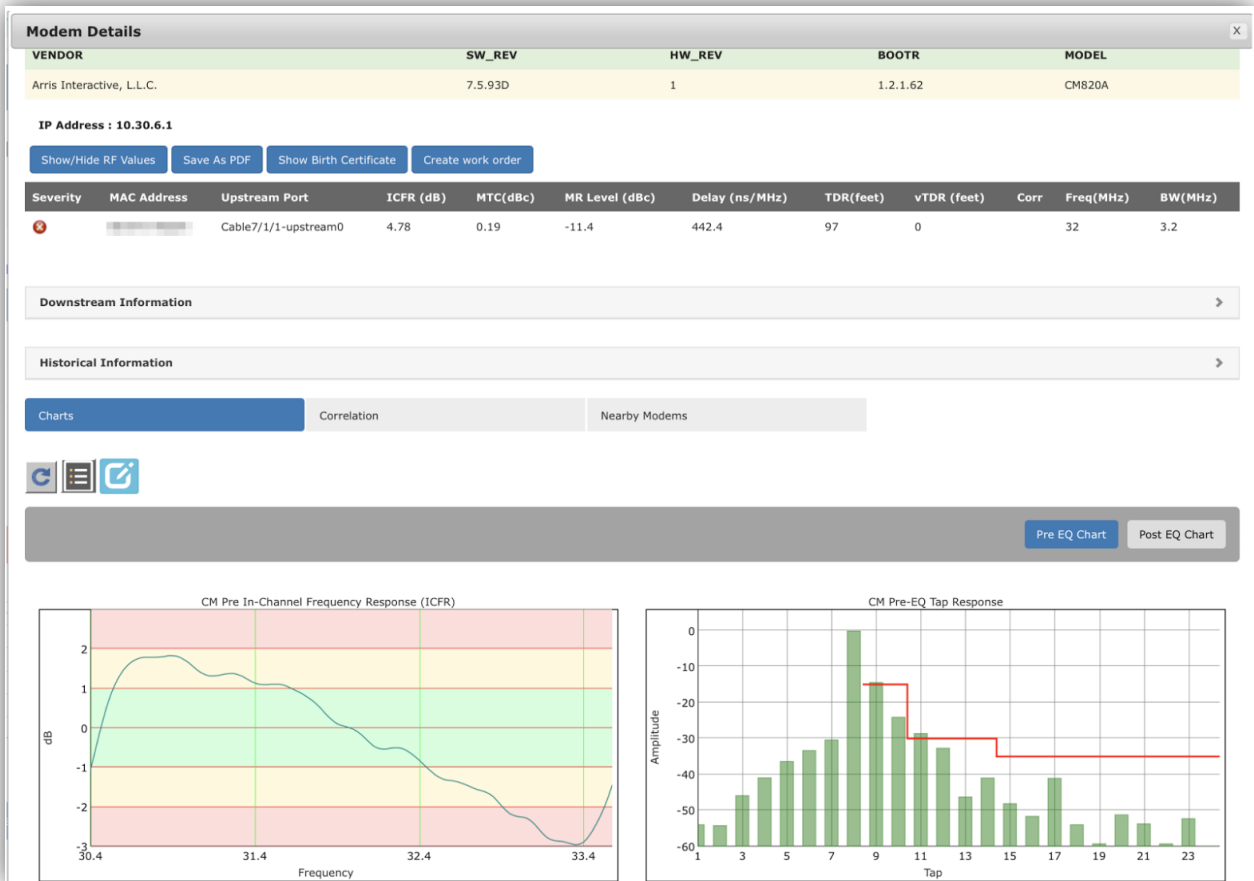
Figure 30: Subscriber 8 Modem Before Repair

Impairment Found: RF leakage was found at a twist on connector at the ground block, and twist-on connectors and splitter at the back of the subscriber’s TV on a common splitter with the modem. Visible braid was wrapped around the center conductor of the connector. In addition the connector at the tap was blackened due to electrical or water damage (hard to tell), and multiple bad connectors and jumpers inside of home. All impairments were detected by ComSonics’ M3 leakage indicated on the QAM Compass. Repair success was verified using the combination of Nimble This PNM and ComSonics M3.

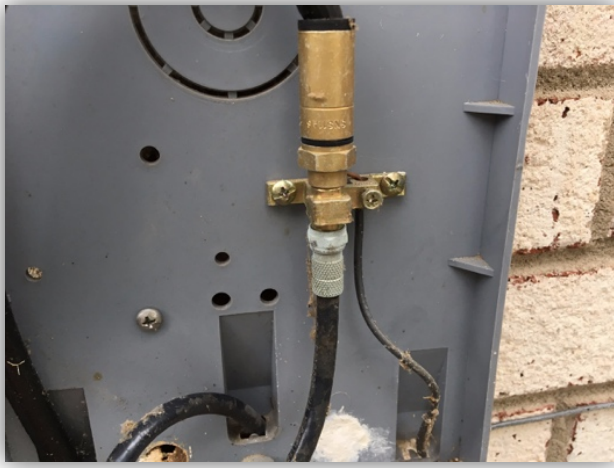
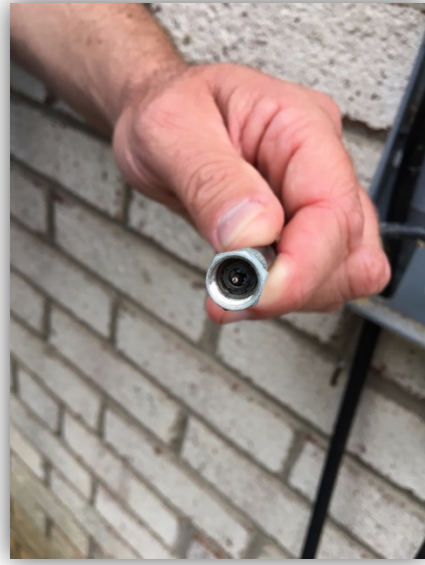
Figure 31: Twist on F-Connector at Ground Block

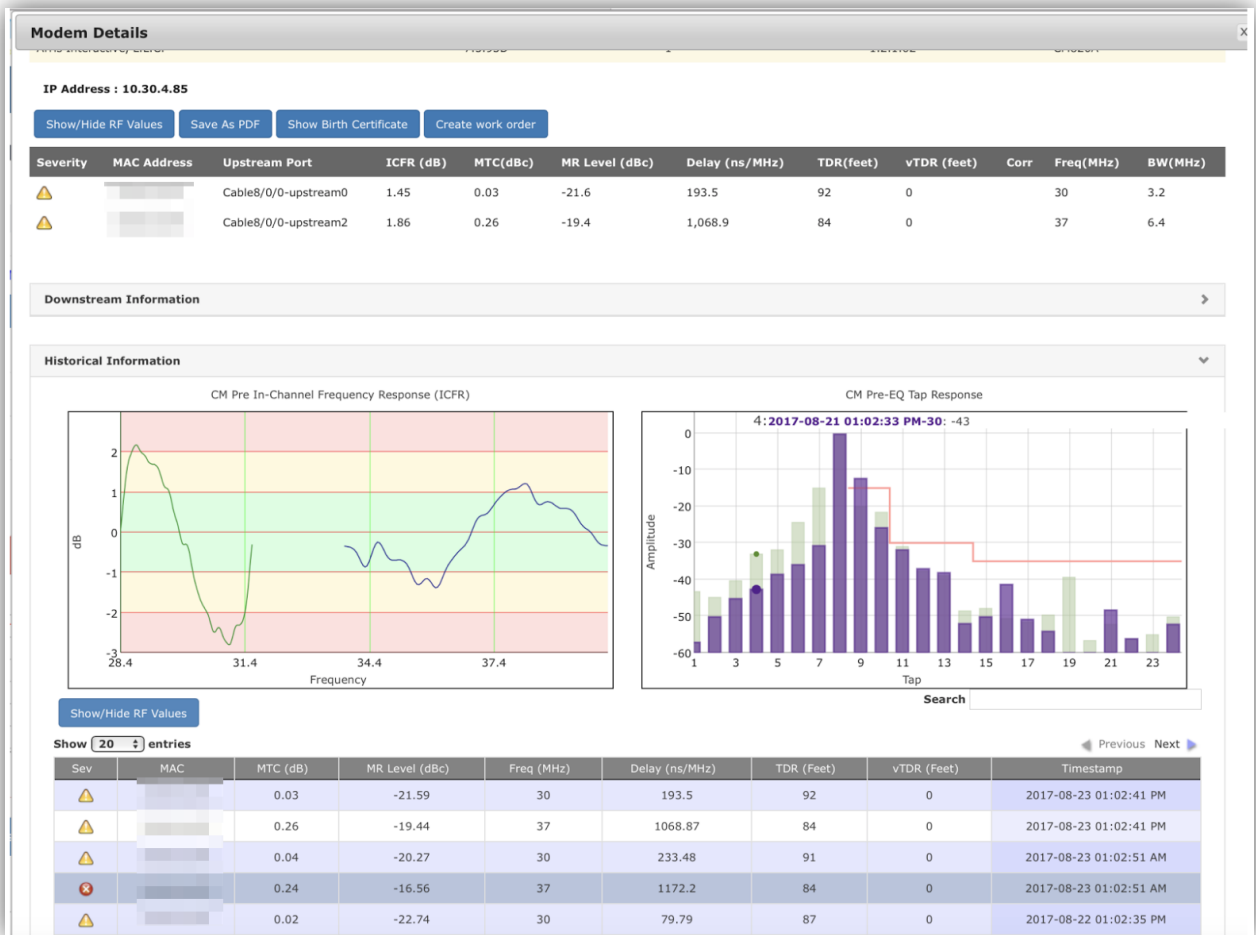
Figure 33: Subscriber 9 Modem Before Repair

Impairment Found: Bad connector at pole ground block and possible bad trap at tap

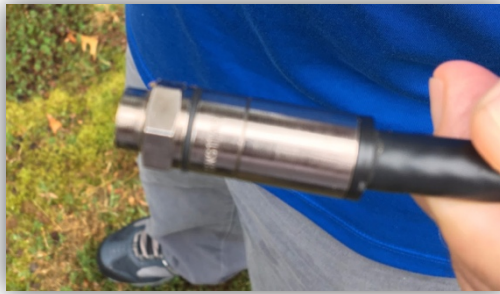
Figure 34: Bad Compression Type F-Connector

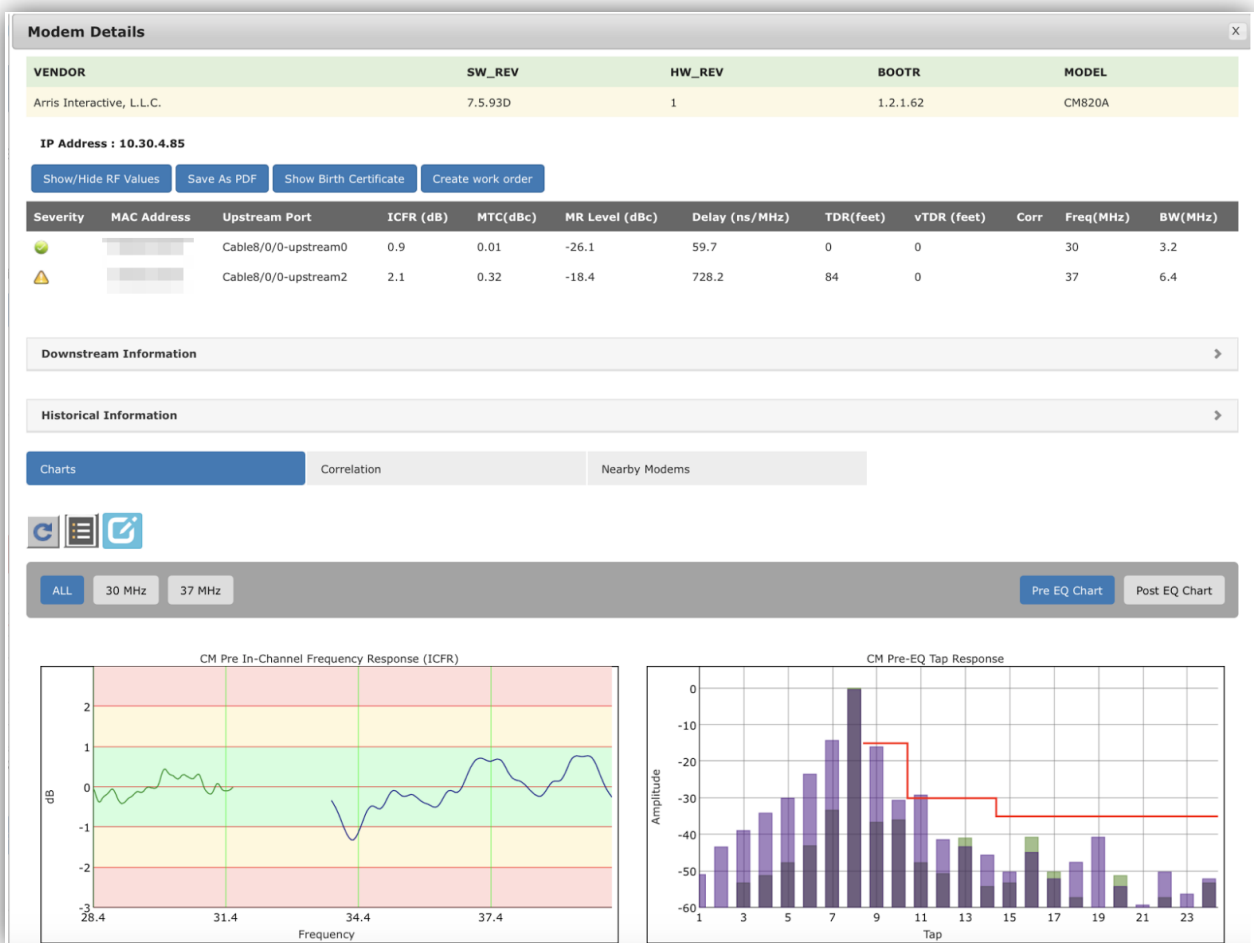
Figure 35: Subscriber 9 Modem After Replacing Bad F-Connector - Note there is still an impairment associated with the outside plant on the upstream near the band edge at 37 MHz

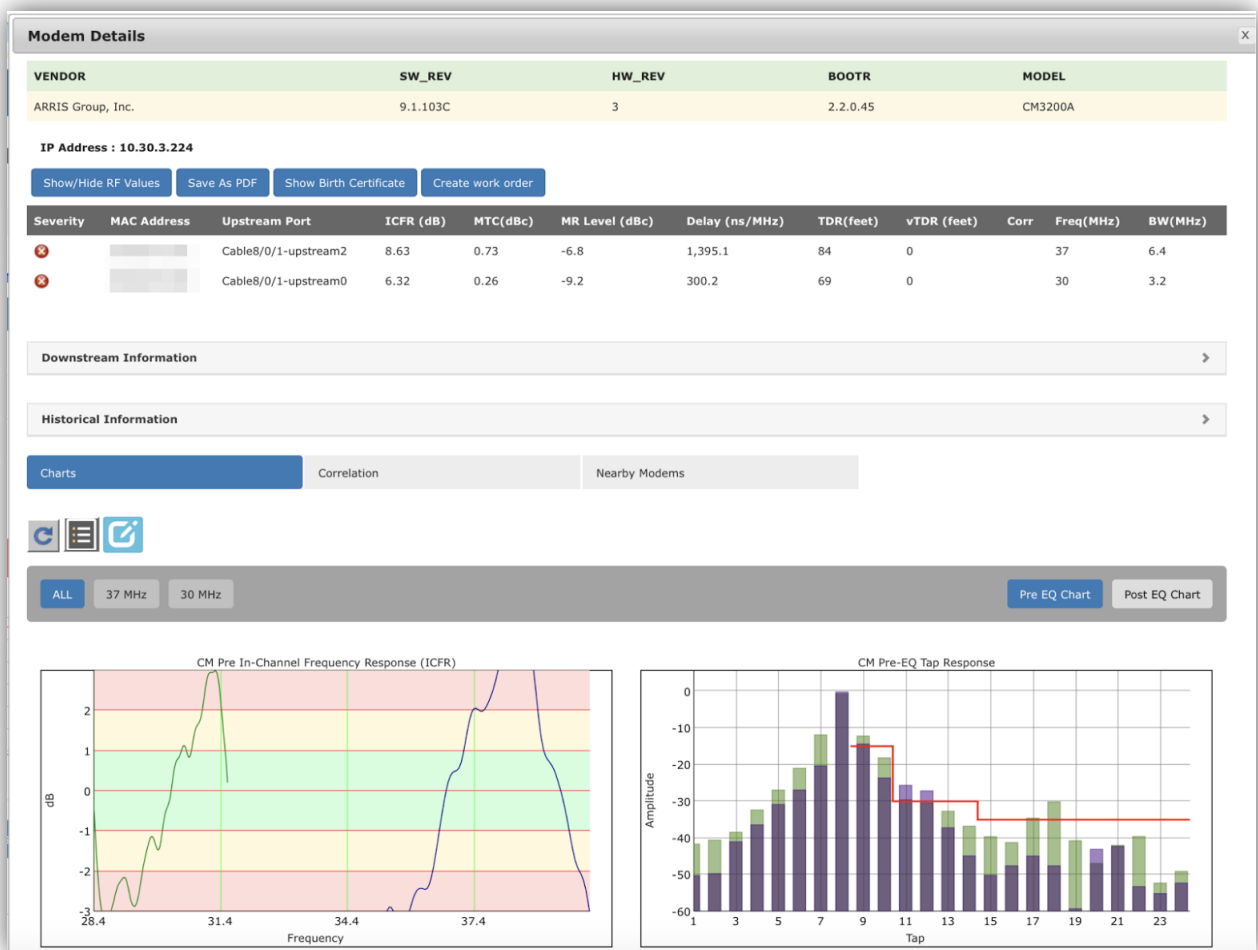
Figure 36: Subscriber 10 Modem Before Repair

Impairment Found: Cable from ground block was connected to an unused Dish TV splitter sitting in a small pond of water hidden in a crawl space under the subscriber dwelling. The splitter was fortunately leaking large ComSonics' M3 test signal amounts, which the QAM Compass made finding it easy. The Dish TV splitter was removed and a direct run was installed to the modem.

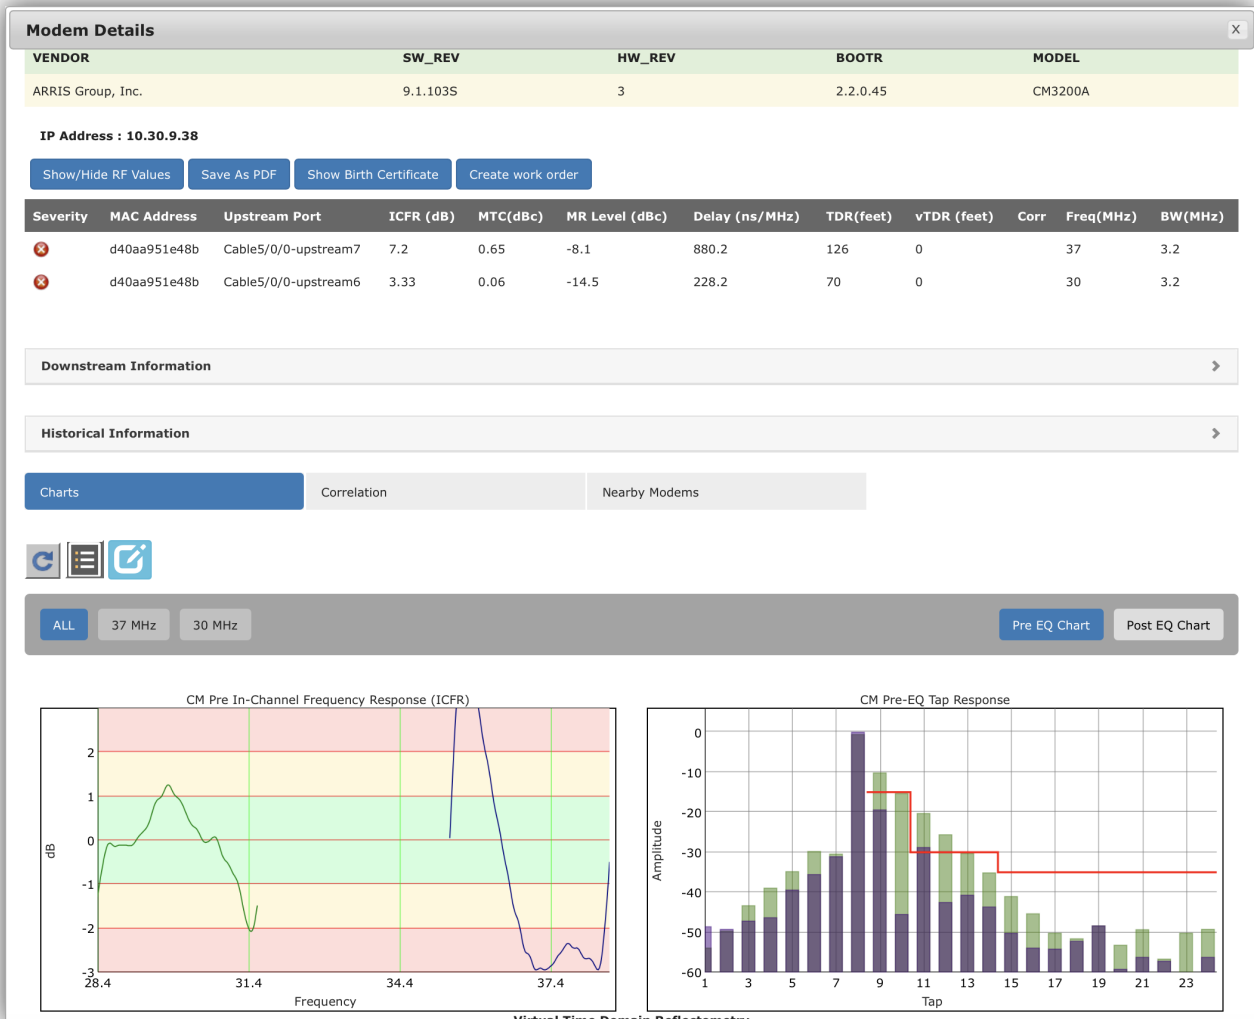
Figure 38: Subscriber 11 Modem before replacing drop

Subscriber 11: Replaced the drop which was damaged or had an existing bad splice (tracked with M3/Compass). Found a unterminated cable outlet inside the house with a very large amount of leakage. The rest of the inside was quiet. After repairs, the downstream improved significantly, but there was still an issue with the modem. The problem was most likely due to a problem on the network side.
