# NIMBLE THIS PROACTIVE NETWORK MAINTENANCE AND COMSONICS SIGNAL LEAKAGE TOOLS

*A Valuable System for Isolating RF Impairments that Radically Aid Drop and  
In-Home / Near Home Issue Resolution*

**NIMBLE THIS LLC AND COMSONICS INC.**

October 10, 2017 :: ver 3

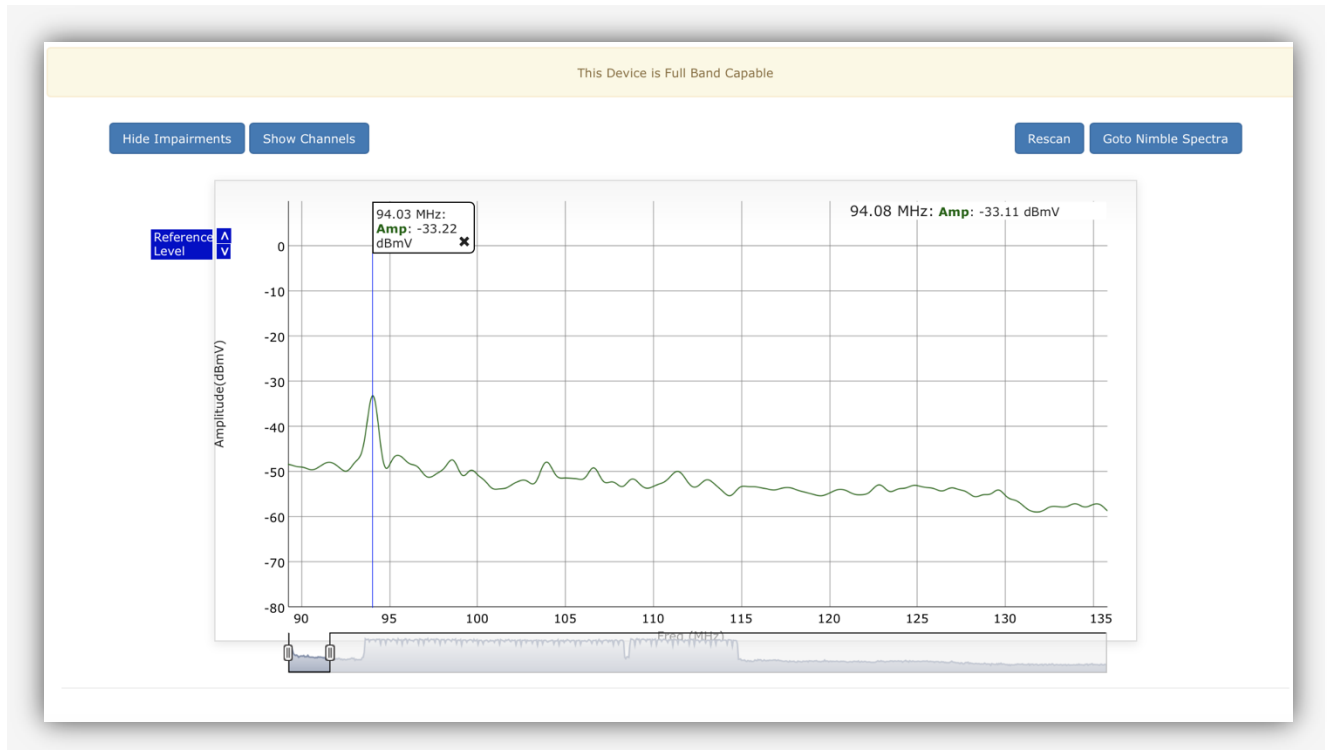
Figure 40: Subscriber 12 Modem Before replacing Connectors

As shown in Figure 40, this subscriber was experiencing FM ingress in the downstream at a frequency of 94.1 MHz. This is an expanded view of the full spectrum capture from the modem. The problem was found to be a series of problems including a bad drop, bad splitter, and crimp-on connectors.

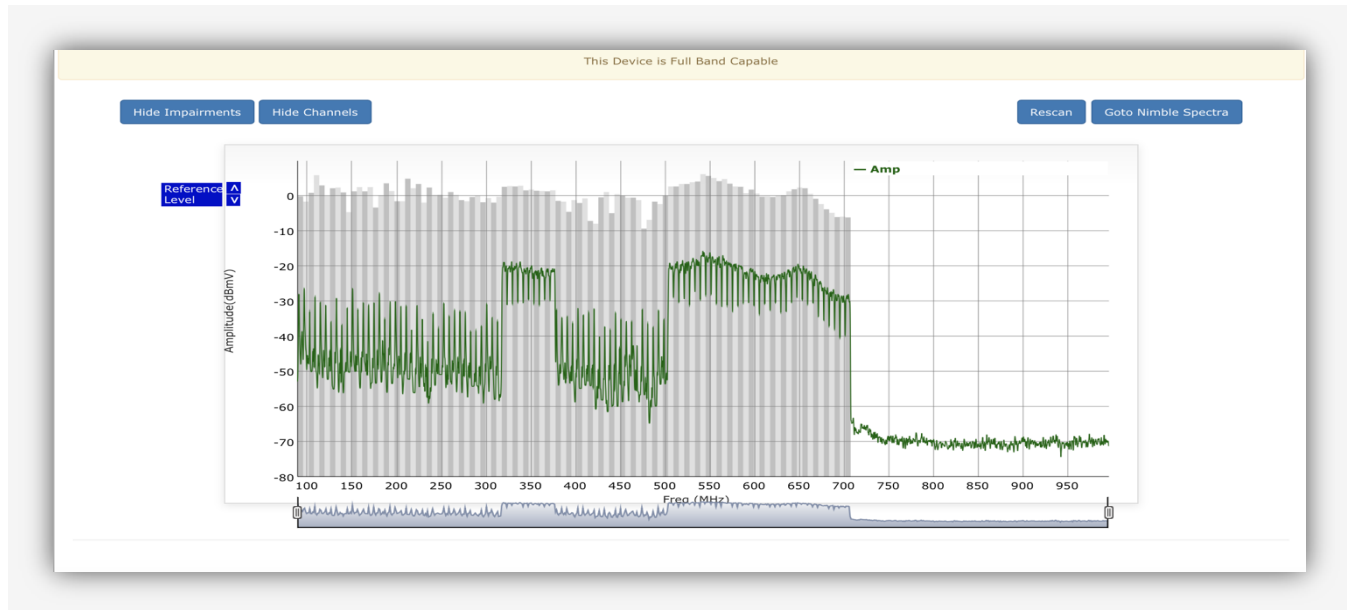
Figure 42: Subscriber 13 Before Repairs. Note the channel suck outs in the 400 MHz range

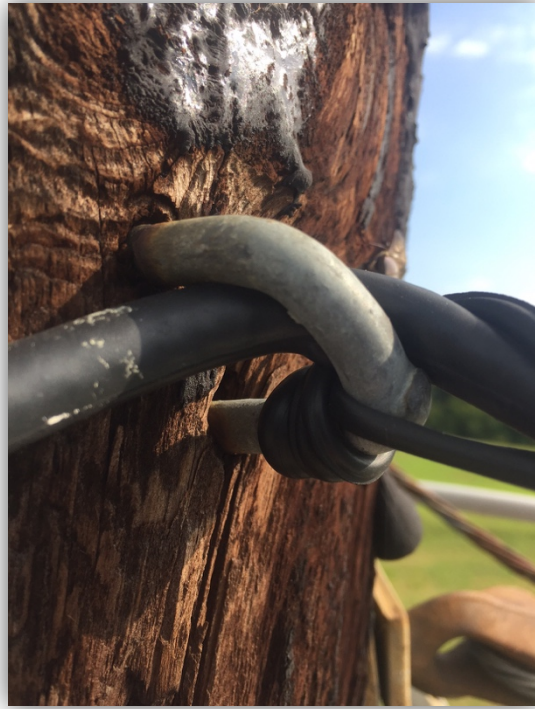
Figure 43: Drop cable looped around a j-hook connector causing the cable shielding to fail.

Replaced complete drop (two sections). The drop was looped around a j-hook causing significant depressions on adjacent sides of the drop. Also added a data only trap. See Figure 43.

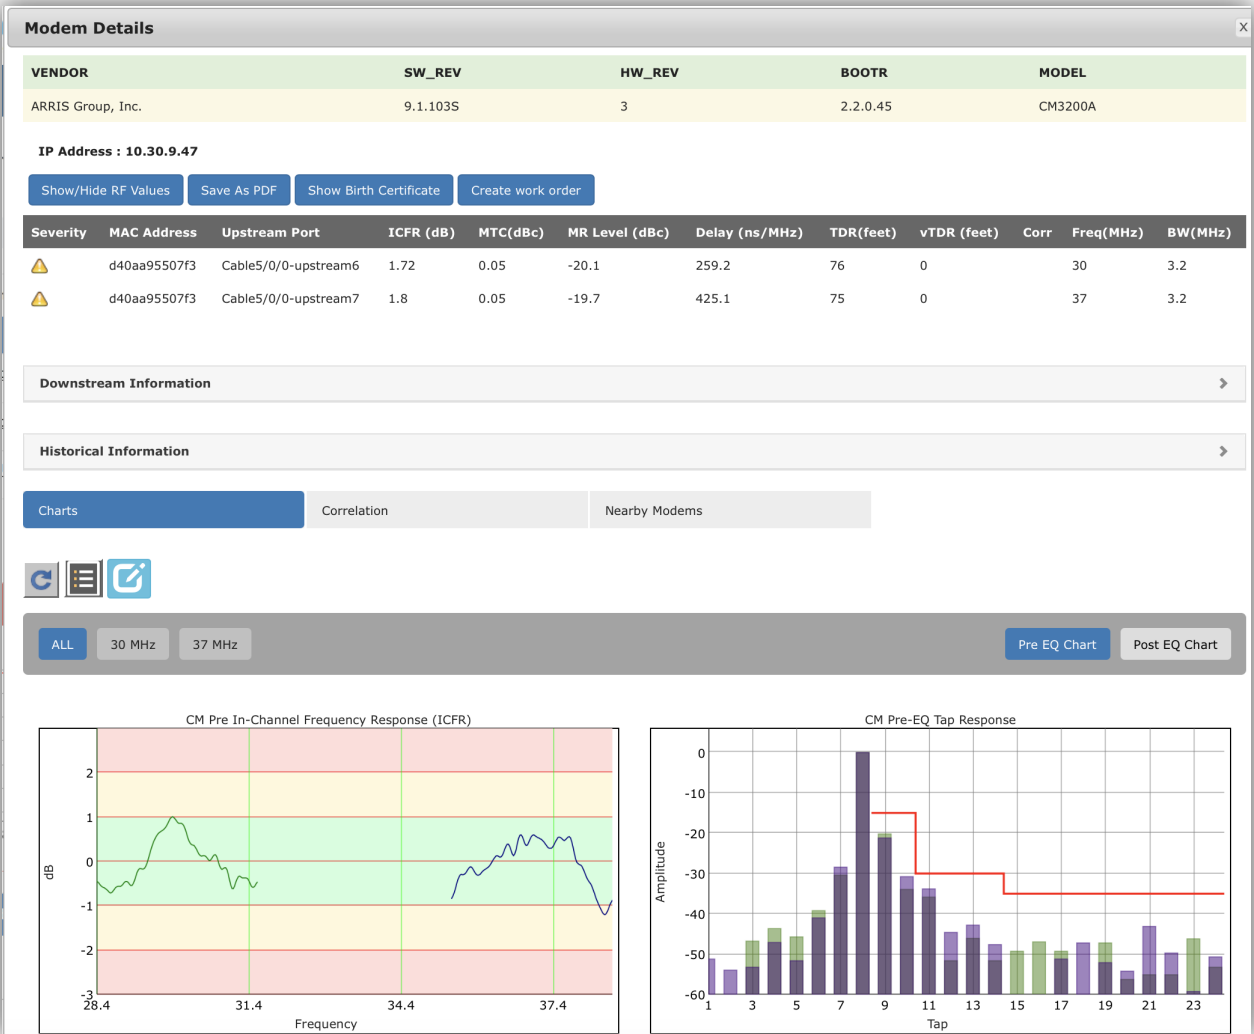
Figure 45: Subscriber 14 Before Repairs

This subscriber was dealing with upstream noise issues, FM Ingress in the downstream, and a bad in-channel frequency response. The downstream level was very low at -18 dBmV. (See Figure 46). After troubleshooting with the M3 and QAM Compass, the drop was found to have multiple leaks. After speaking with the homeowner, it was revealed that the drop was buried shallow, just under the grass. The grass has been aerated several times and we suspected that the lawn aerator hit the cable line. The cable was also missing an earth ground / ground block. After replacing the drop, the downstream level increased from -18 dBmV to +2 dBmV.

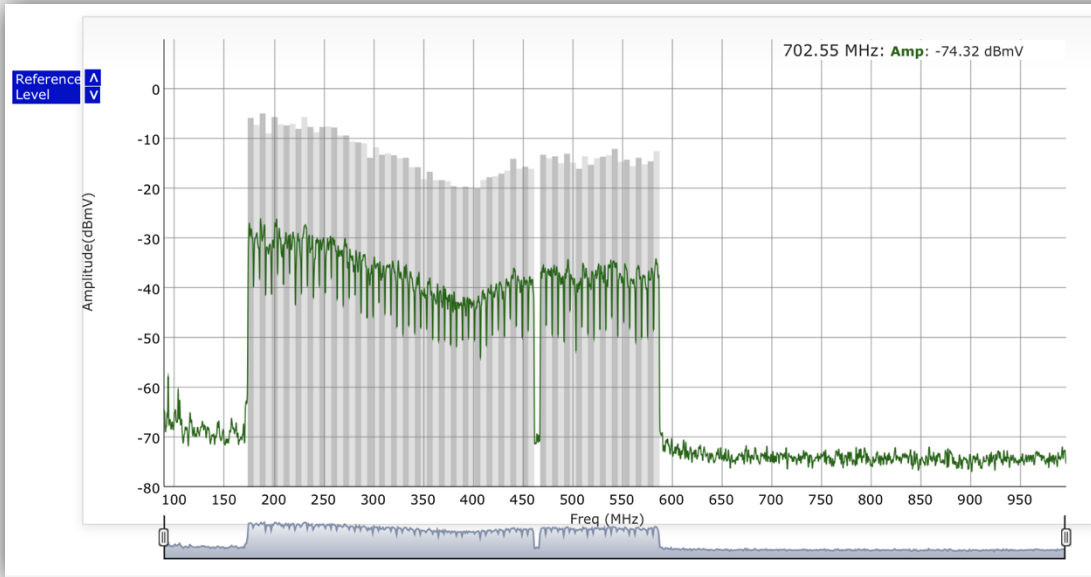
Figure 46: Subscriber 14 Levels before Repair. The levels drop to about -18 dBmV at 400 MHz

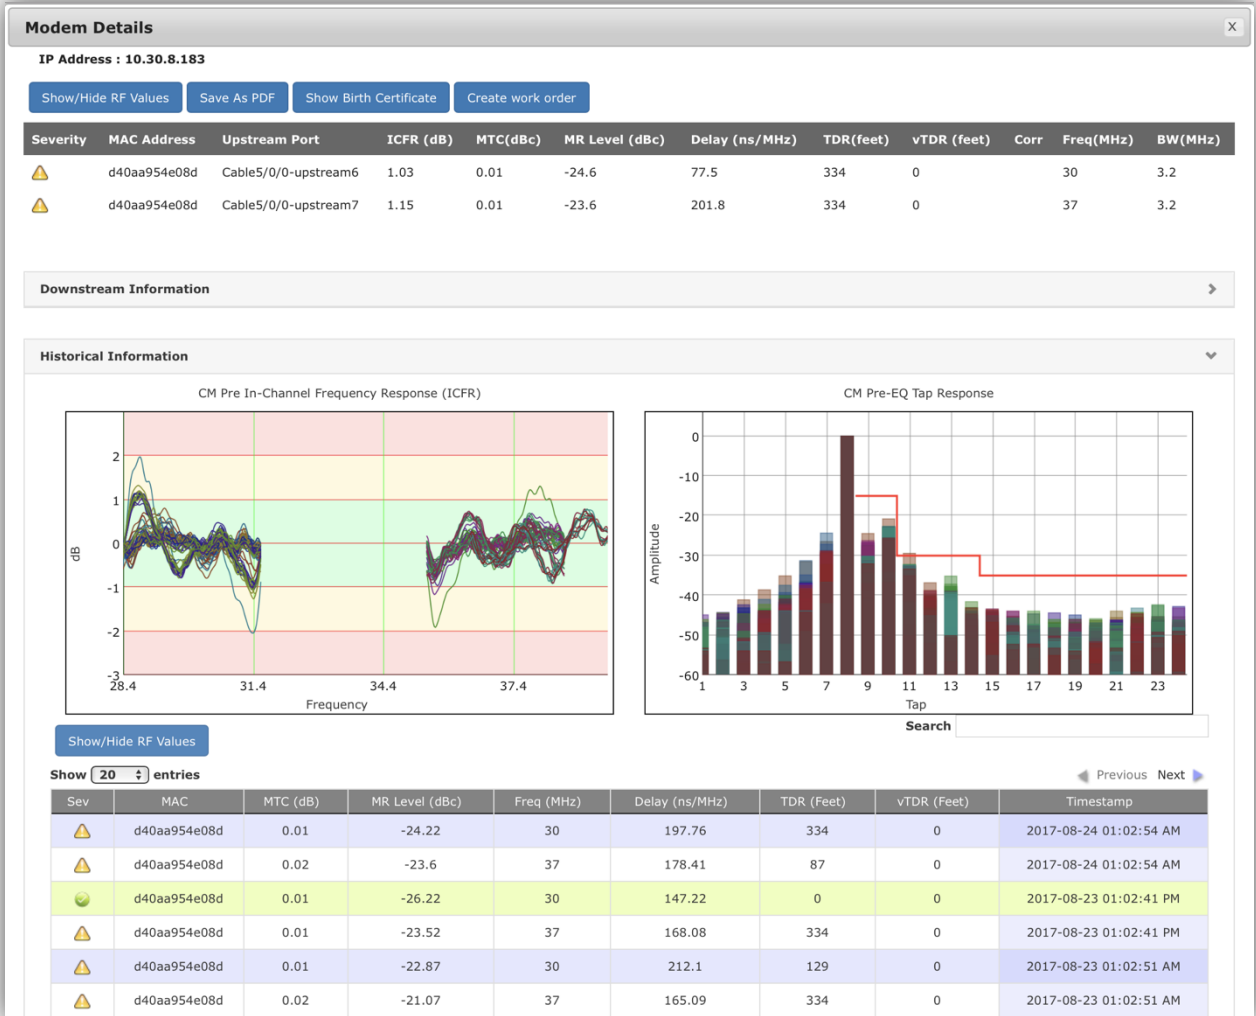
Figure 49: Subscriber 15 Before repair

Problems found in crimp on connectors, a defective multiport splitter and a house amp that was not needed. Repaired all problems found which dramatically improved the return path channel response and returned the modem to a green status.
