# NIMBLE THIS PROACTIVE NETWORK MAINTENANCE AND COMSONICS SIGNAL LEAKAGE TOOLS

*A Valuable System for Isolating RF Impairments that Radically Aid Drop and  
In-Home / Near Home Issue Resolution*

**NIMBLE THIS LLC AND COMSONICS INC.**

October 10, 2017 :: ver 3

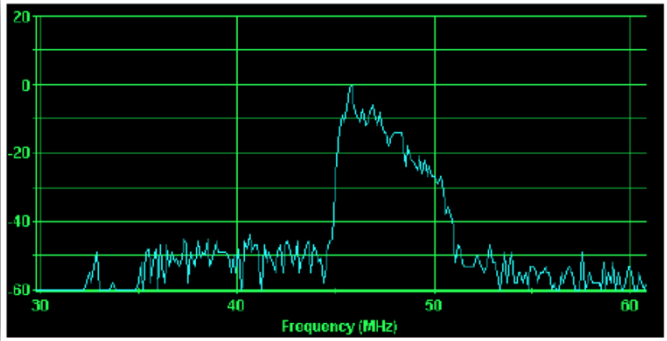
Figure 1: DOCSIS Upstream Signal at CMTS Before Pre-equalization

An illustration of a cable modem signal is perhaps the best way to demonstrate pre-equalization in action. Figure 1 shows an upstream cable modem signal as seen at the CMTS. This RF signal shows significant roll-off due to plant impairments. This would cause the CMTS to have difficulty demodulating the signal, resulting in codeword errors, lost subscriber data and poor subscriber quality of experience (QoE)

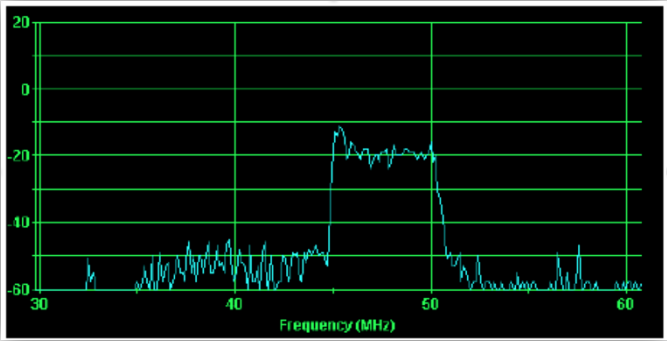
Figure 2: DOCSIS Upstream Signal at CMTS After Pre-equalization

Now the value of DOCSIS pre-equalization should be clear. What was once a very poor looking signal at the CMTS (Figure 1) is now a near-perfect signal at the CMTS (Figure 2) thanks to pre-

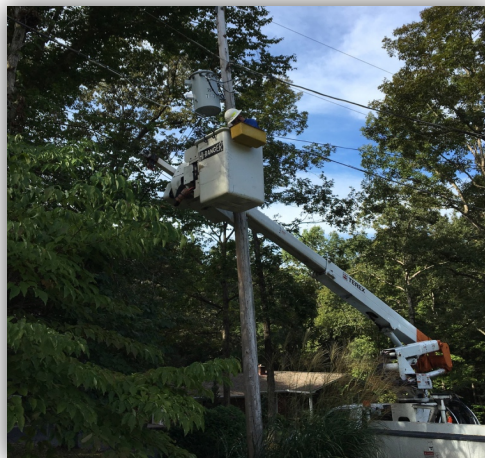
Figure 5: Technician installing M3 Signal Injector

At subscriber 1's house we knew there is a micro-reflection based on the Nimble This PNM data. There are two approaches to fix the problem. The first and most common approach is to replace connectors, splitters and maybe even the drop until the modem status turns from red to green. The second and quicker option is to disconnect the drop at the mainline tap, connect ComSonics' M3, which injects high level RF signals and then look for RF leaks along the drop and inside the home with the ComSonics QAM Compass. Figure 5 shows the technician installing the M3 at the tap end of the drop.

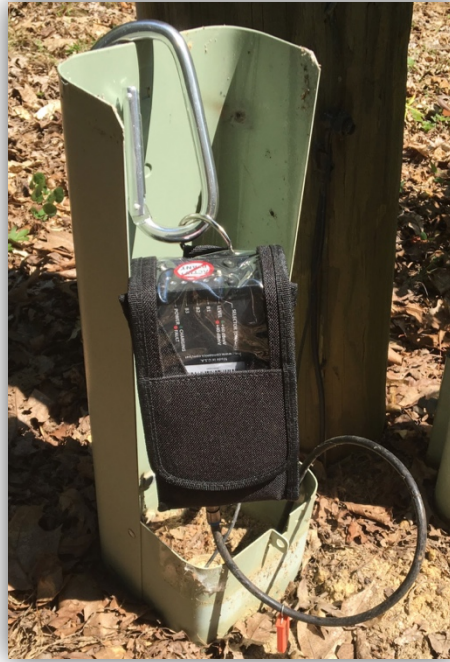
Figure 10: ComSonics' M3 Connected to Buried Subscriber Drop Cable

As shown in Figure 10 the drop is buried and ComSonics' M3 is connected to that drop.

Once connected and powered up, the M3 transmits high signal levels into the subscriber's drop and home (not the HFC plant!). Almost immediately the ComSonics' QAM Compass detected a leak. The technician started walking around the subscriber's house where low level signals appeared present nearly everywhere. Over a period of five minutes the technician found the highest signal level to be near the buried drop cable. This indicated that the RF leak was coupled to the shield of the drop cable buried underground.

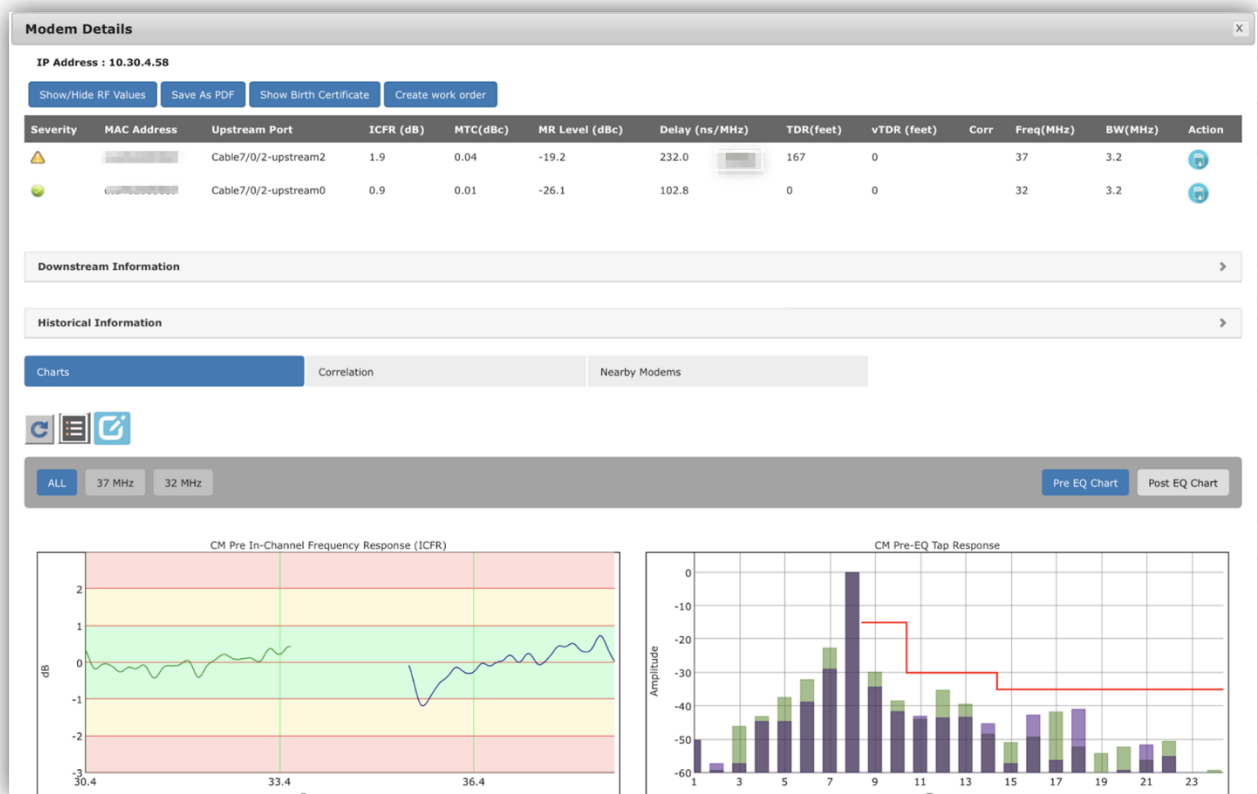
Figure 15: Subscriber 2 Modem After Splice and Trap Repair

The red filter was removed and replaced with a new one. It is possible that the filter was damaged by lightning or failed with age. Upon rescanning the cable modem with the Nimble This PNM application the modem returned a near perfect upstream response as seen in Figure 15.

Note that the second upstream (37 MHz) on the modem in Figure 15 has a slight group delay impairment which is common to all modems in this part of the RF spectrum. The group delay

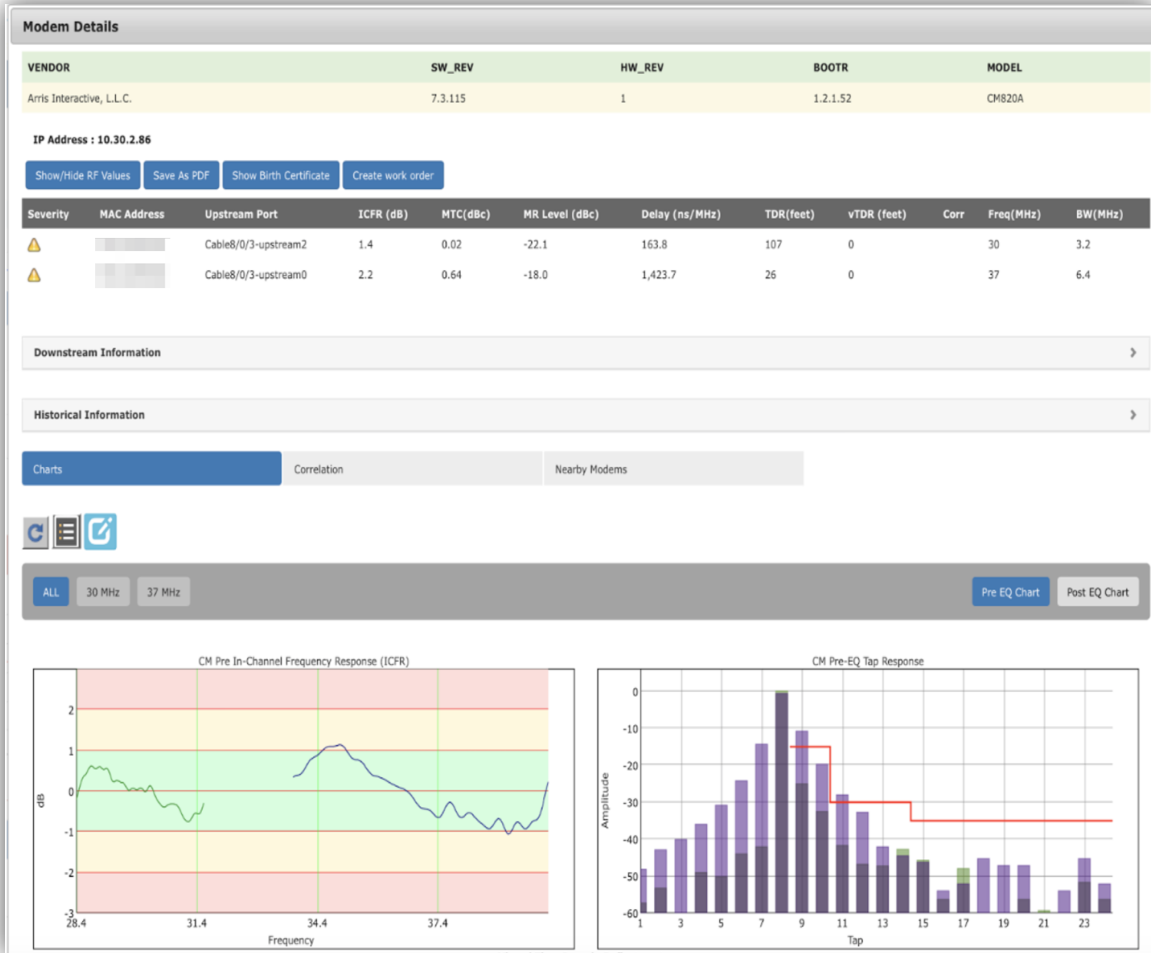
Figure 18: Subscriber 3 Modem After Repair of Twist-On F-Connectors

Upon completing the work, all RF leakage stopped and leaks were no longer detectable with the ComSonics' QAM Compass. The drop was reconnected and the Nimble This PNM mobile app was used to rescan the modem. The modem(s) performance was found to be significantly improved except for the group delay present on the upstream as seen on Subscriber #2's modem. This response can be seen in Figure 18.

Note the elevated taps (in purple) are due to significant group delay in this section of plant. This cannot be fixed at the subscriber home, but was later fixed by replacing a faulty duplex filter in a fiber node.

The splitter was removed and terminated at the single twist-on F-connector feeding the splitter, but substantial RF leakage was still detected. This indicated the primary source of leakage was the single twist-on F-connector. All twist-on F-connectors were replaced with

weatherproof Snap-N-Seal compression F-Connectors and the splitter was replaced and relocated to the existing house box.

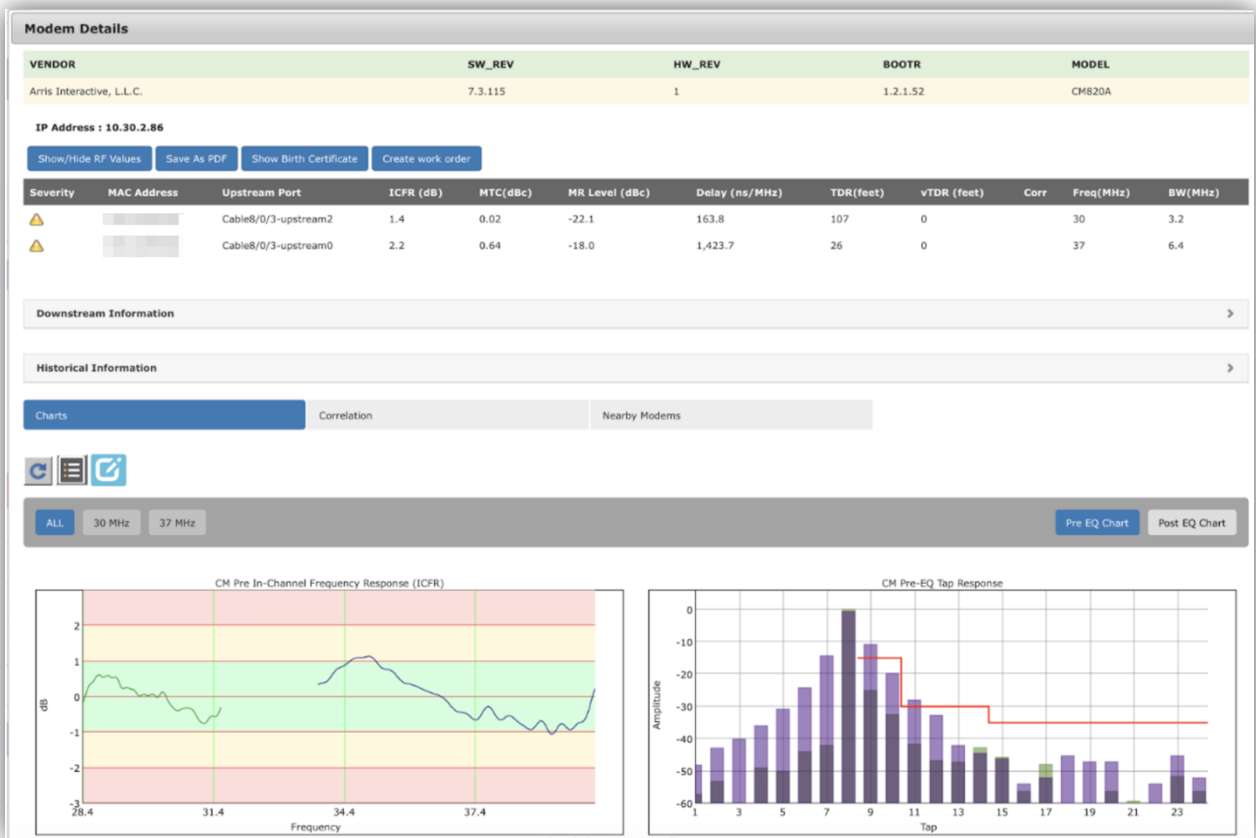
Figure 21: Subscriber 4 Modem After Repair of Crimp-on F-Connector

Upon rescanning the modem with the Nimble This PNM mobile app the modem pre-equalizer response confirmed that the majority of the impairment had been resolved turning the modem from red to yellow, however the leak in the crawl space was likely preventing the modem from turning to green. Figure 21 shows the modem's response after repairing the crimp-on F-connector on the back of the modem.

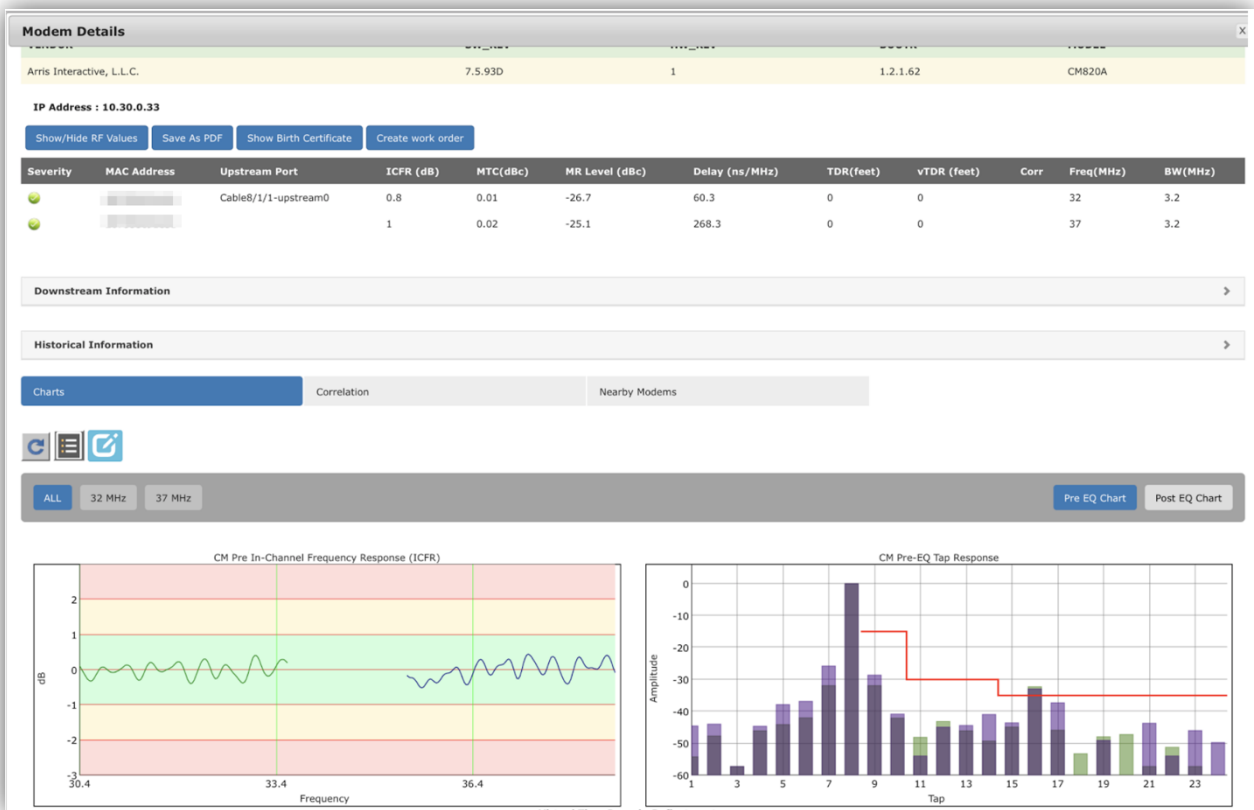
Figure 24: Subscriber 5 Modem After Replacing Bad Drop

Upon replacing the drop cable all signs of RF leakage disappeared. Further, upon reconnecting the drop and rescanning the modem using the Nimble This PNM mobile app it was found that not only had the original upstream channel turned from red to green, but the modem was no longer in partial mode. Now the modem was able to bond to both upstream channels and both upstream channels were green with minimal micro-reflections, as can be seen in Figure 24.

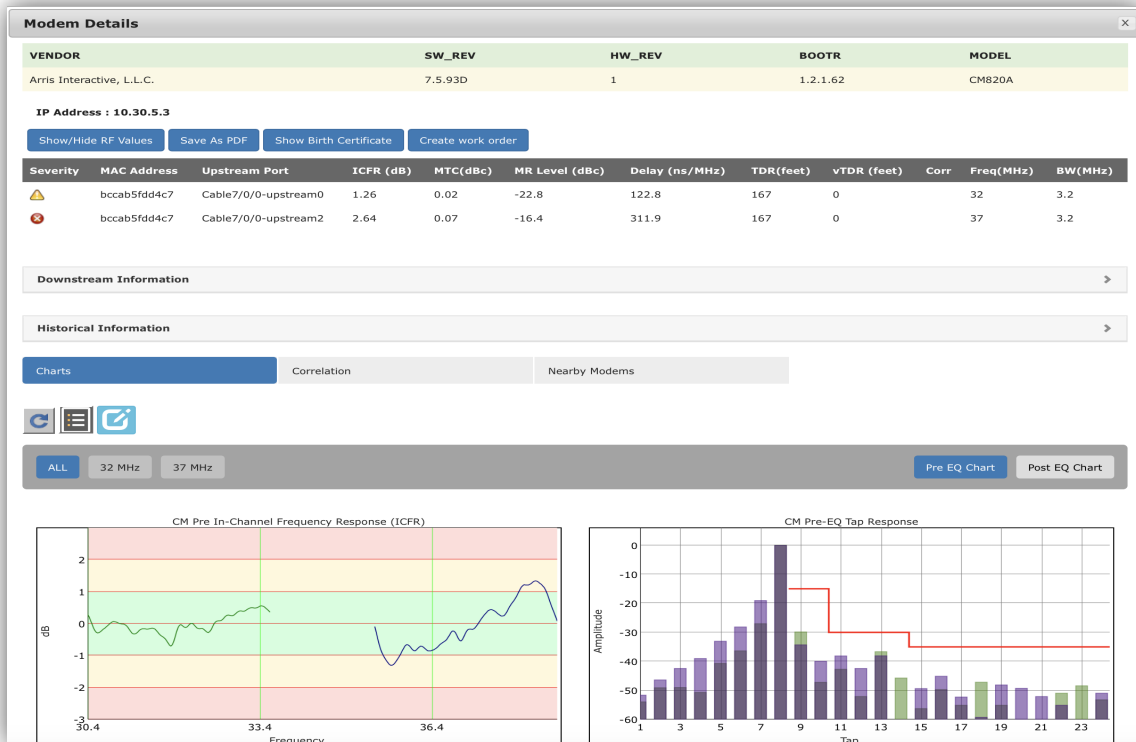
Figure 27: Subscriber 6 Modem After Repair

Impairment Found: Intermittent issue due to faulty TVC Arrestor Ground Block. The faulty ground block shown in Figure 26 was only detected because it was leaking significant amounts of ComSonics' M3 RF energy. Faulty ground blocks are not common, but it is assumed this "surge arresting" type ground block had been damaged by a surge.

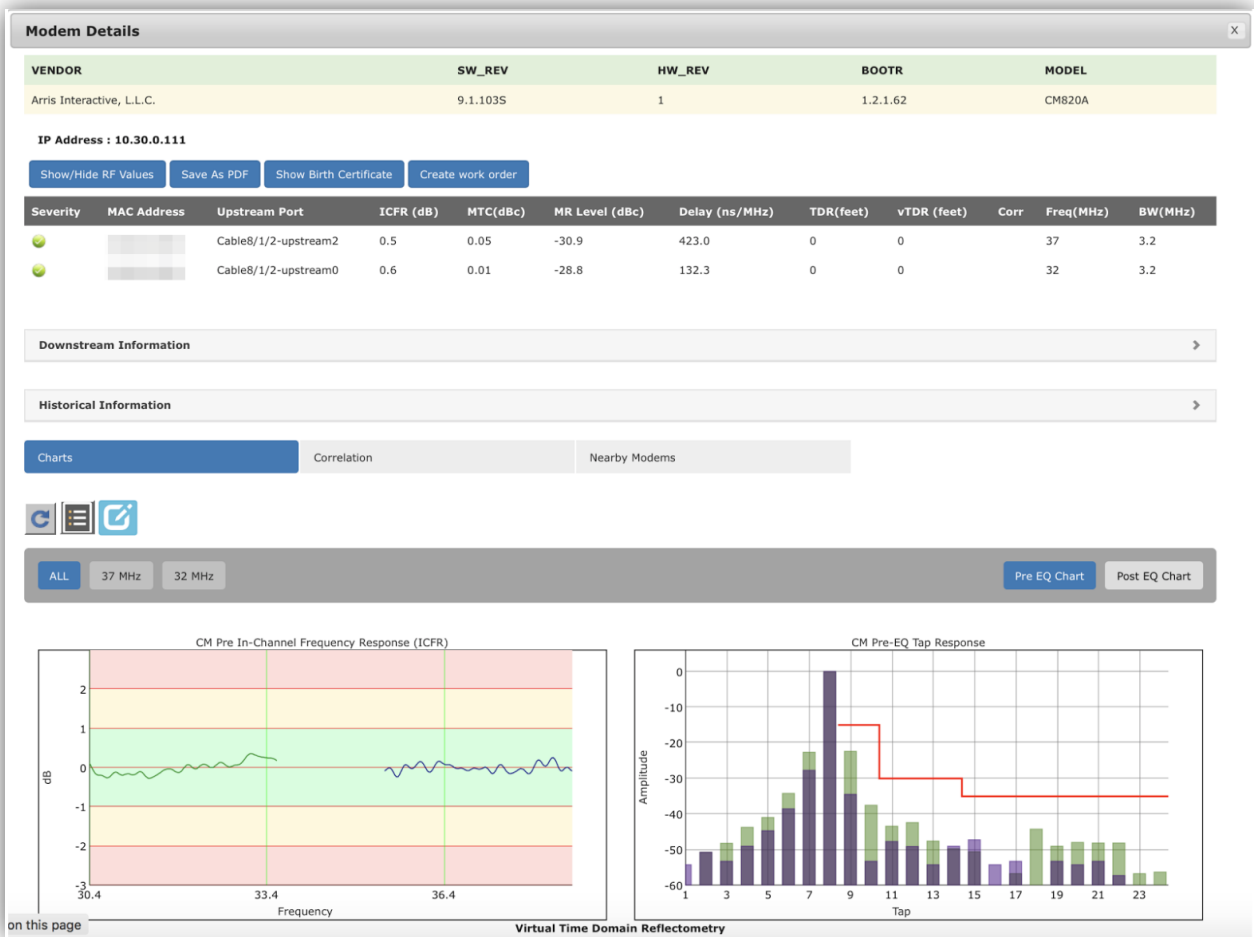
Figure 29: Subscriber 7 Modem After Repair

Impairment Found: Multiple leaks inside the house due to crimp-on style F-connectors and an unnecessary house-amp in front of the modem. Upon replacing all older style connectors with quality connectors, no leaks were observed, and the modem response in Figure 29 resulted.

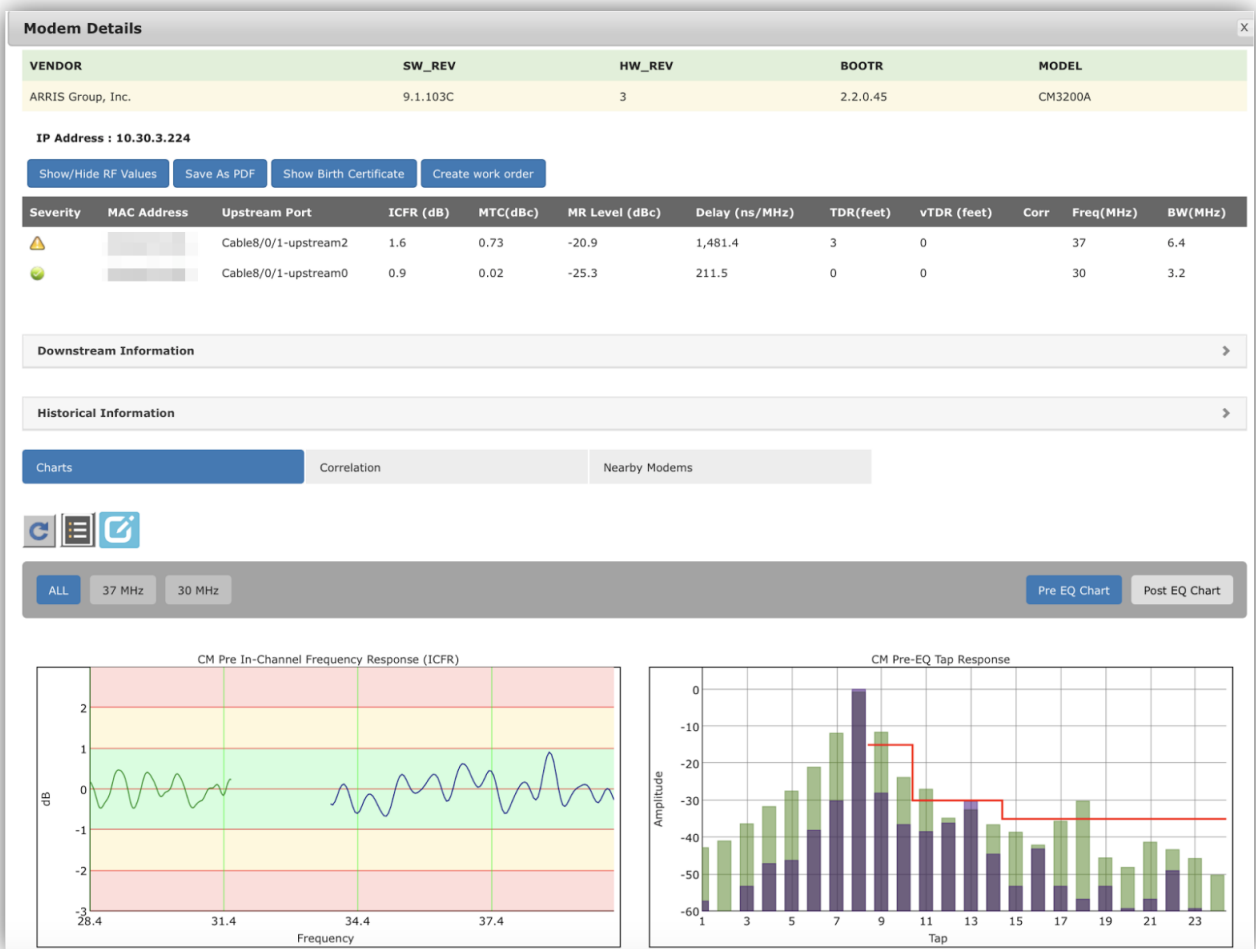
Figure 37: Subscriber 10 Modem After Removing Dish TV Splitter (Impairment at upper channel due to outside plant)

Impairment Found: Cable from ground block was connected to an unused Dish TV splitter sitting in a small pond of water hidden in a crawl space under the subscriber dwelling. The splitter was fortunately leaking large ComSonics' M3 test signal amounts, which the QAM Compass made finding it easy. The Dish TV splitter was removed and a direct run was installed to the modem.

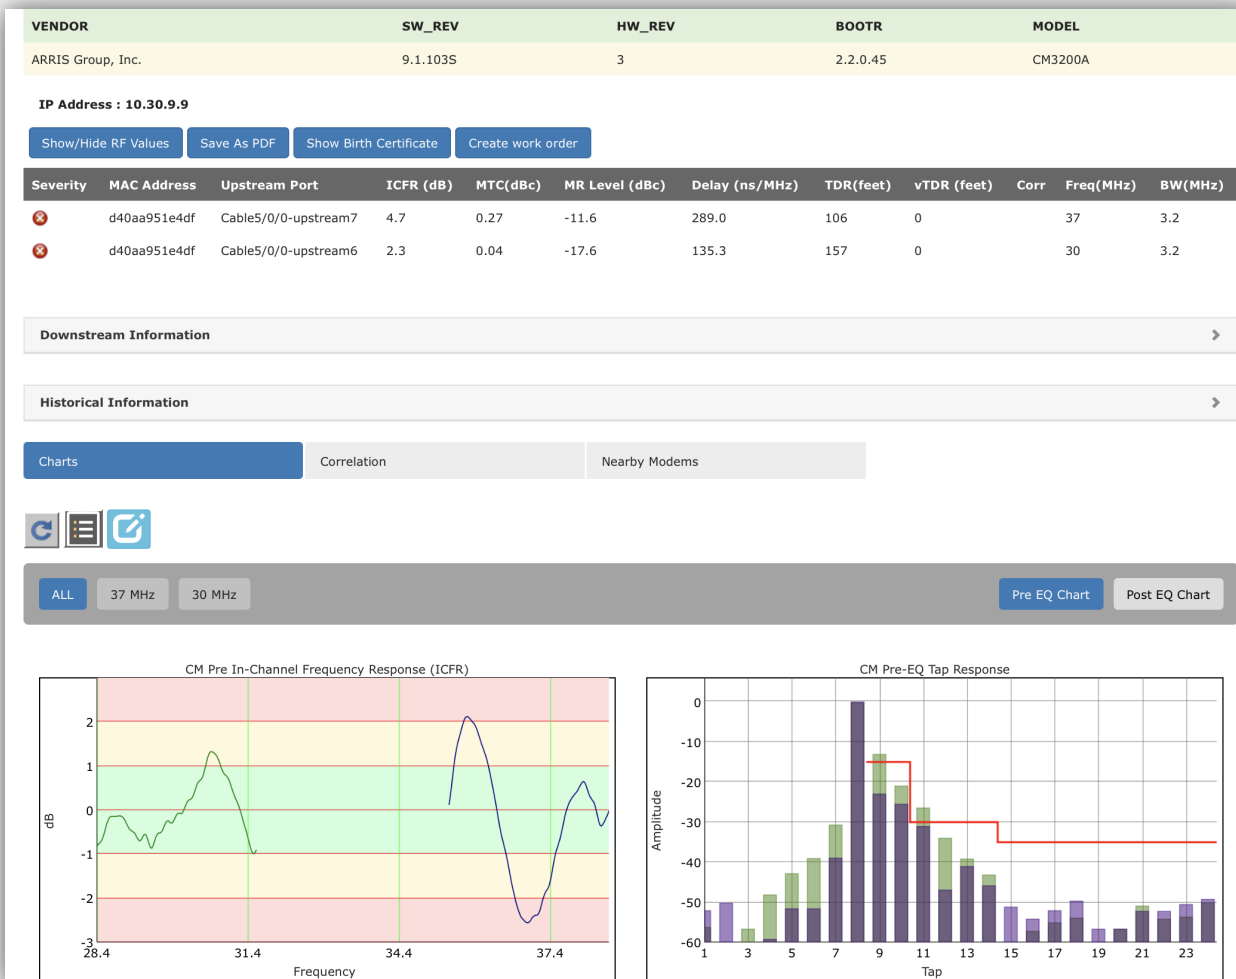
Figure 39: Subscriber 11 Modem After replacing drop

Subscriber 11: Replaced the drop which was damaged or had an existing bad splice (tracked with M3/Compass). Found a unterminated cable outlet inside the house with a very large amount of leakage. The rest of the inside was quiet. After repairs, the downstream improved significantly, but there was still an issue with the modem. The problem was most likely due to a problem on the network side.

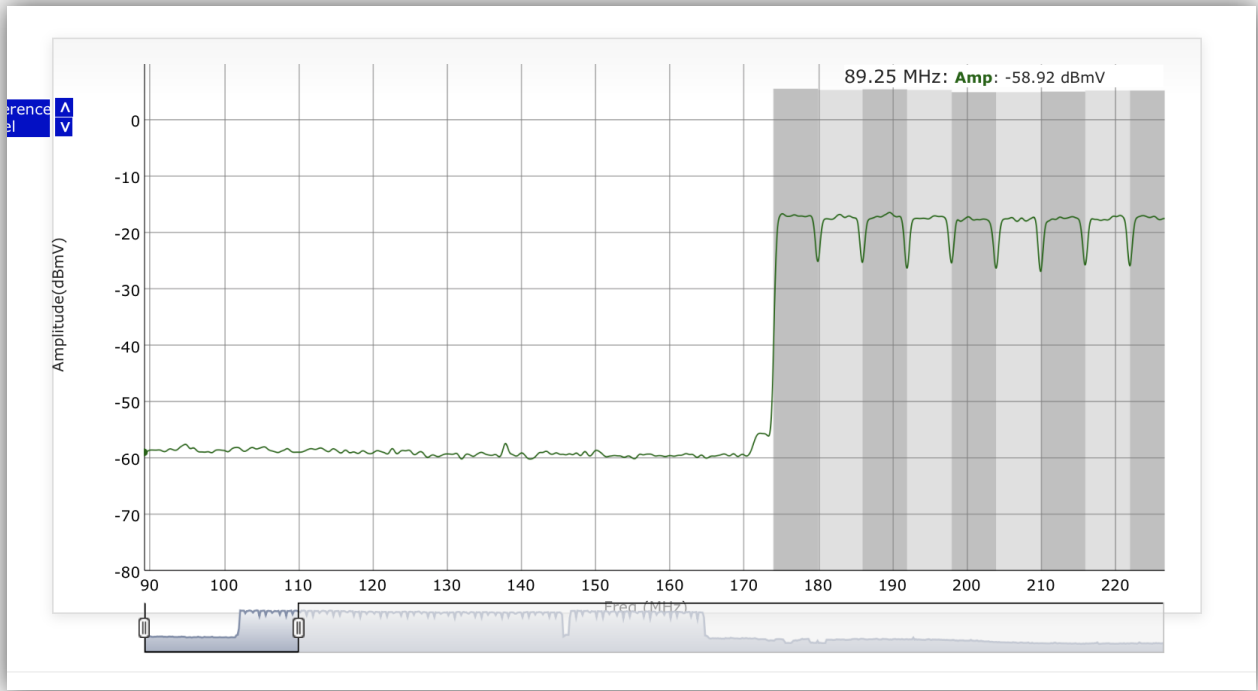
Figure 41: Subscriber 12 After replacing Drop and Bad Connectors. Note that the FM ingress is gone at 94 MHz

As shown in Figure 40, this subscriber was experiencing FM ingress in the downstream at a frequency of 94.1 MHz. This is an expanded view of the full spectrum capture from the modem. The problem was found to be a series of problems including a bad drop, bad splitter, and crimp-on connectors.

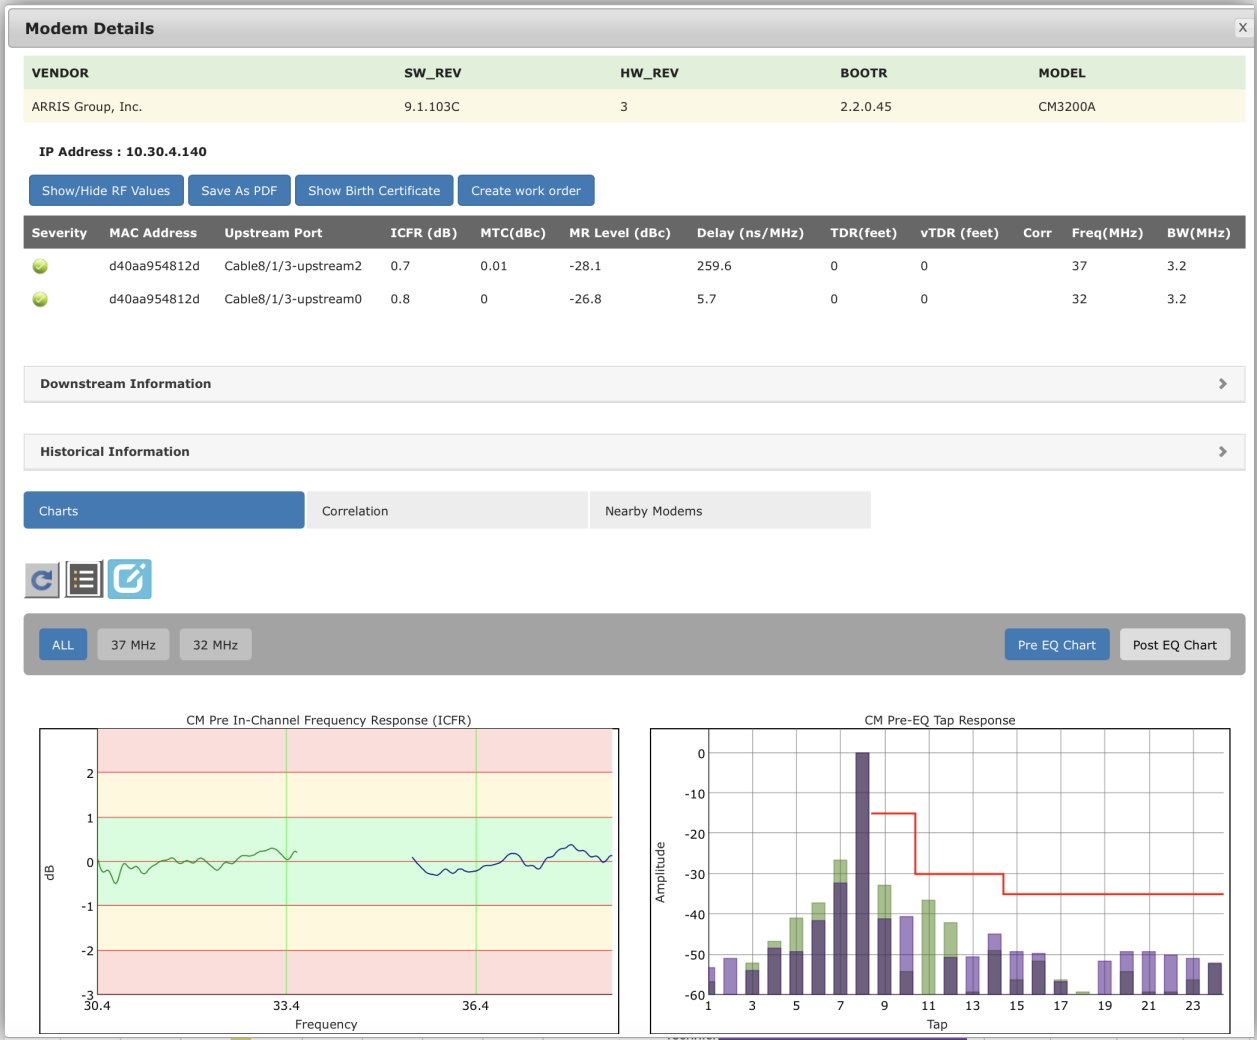
Figure 44: Subscriber 13 After Repairs

Replaced complete drop (two sections). The drop was looped around a j-hook causing significant depressions on adjacent sides of the drop. Also added a data only trap. See Figure 43.

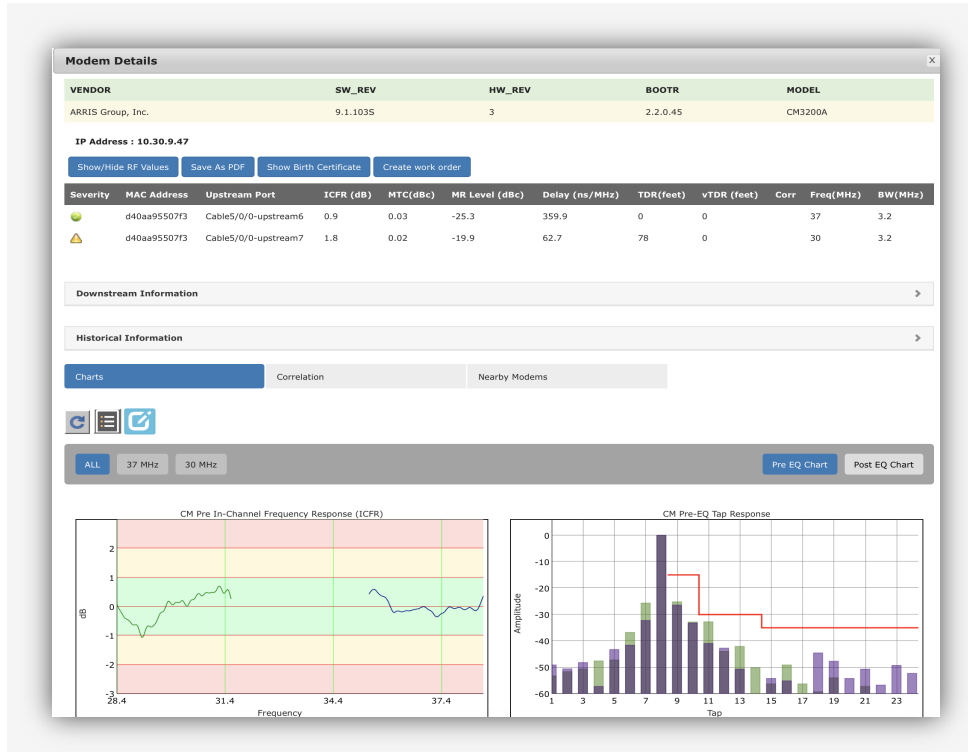
Figure 47: Subscriber 14 After repair. In-Channel frequency response has improved

This subscriber was dealing with upstream noise issues, FM Ingress in the downstream, and a bad in-channel frequency response. The downstream level was very low at -18 dBmV. (See Figure 46). After troubleshooting with the M3 and QAM Compass, the drop was found to have multiple leaks. After speaking with the homeowner, it was revealed that the drop was buried shallow, just under the grass. The grass has been aerated several times and we suspected that the lawn aerator hit the cable line. The cable was also missing an earth ground / ground block. After replacing the drop, the downstream level increased from -18 dBmV to +2 dBmV.

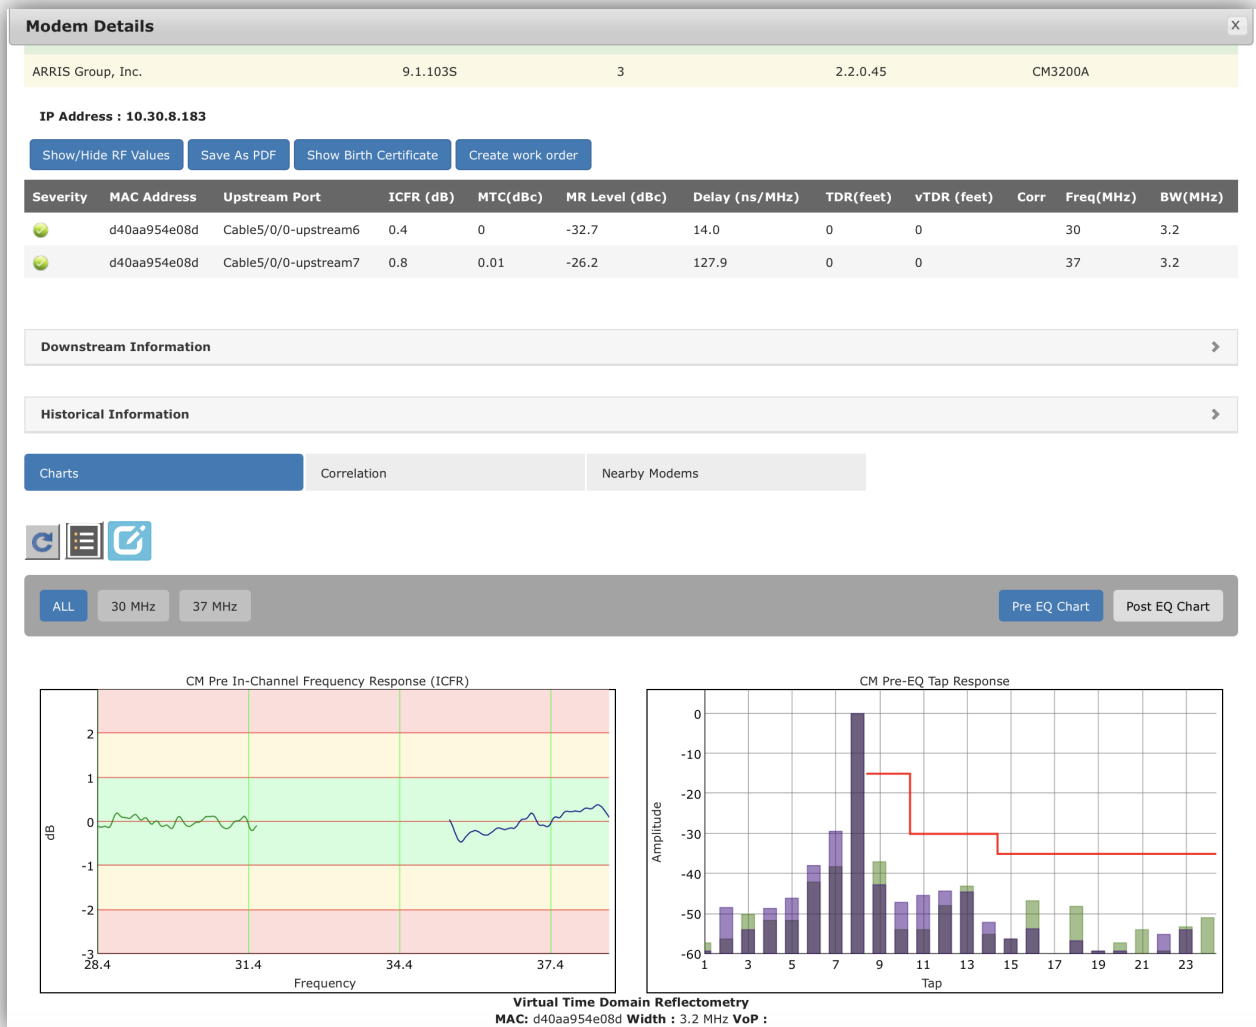
Figure 50: Subscriber 15 After Repair

Subscriber 15 exhibited problems of intermittent upstream, FM ingress and tilt in the downstream.

Problems found in crimp on connectors, a defective multiport splitter and a house amp that was not needed. Repaired all problems found which dramatically improved the return path channel response and returned the modem to a green status.
